CASE STUDY

FTIS™ DETECTS METALLURGICAL CHANGES

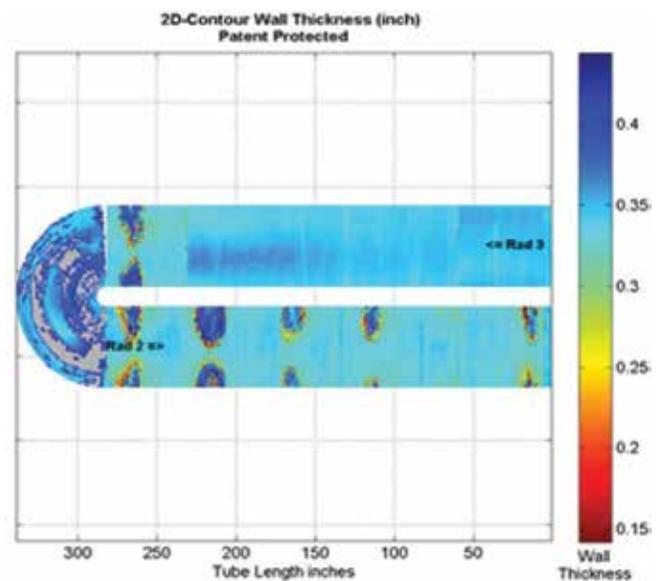
Figure 1. Anomalies as seen in two tubes joined by a return bend

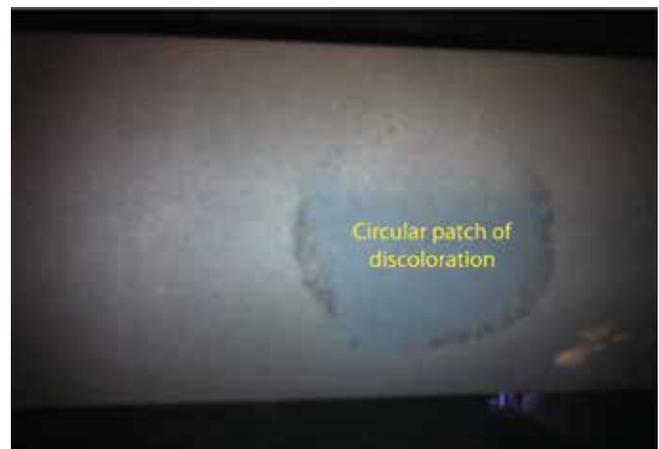
Figure 2. View of anomaly on exterior tube surface

In the meantime, Quest Integrity conducted detailed engineering evaluations of specific coil sections removed from the heater. It was not known if these tubes would show similar results. These tubes were inspected at our Seattle facility and similar anomalies were detected (see Figures 2 and 3). Both the internal and external surfaces were visible to the unaided eye, and it was clear there was no build-up on the tube wall to account for the apparent increase in wall thickness. Subsequently, the anomaly locations were marked and the tubes were sent to our Denver office for metallurgical analysis. It was determined a unique, high temperature corrosion process was taking place, resulting in a depletion of chromium (e.g. de-alloying) from the base metal and leaving behind a porous magnetic nickel iron alloy corrosion layer. This change in the composition affected the physical properties (e.g. UT sound velocity) of the corroded layer and caused an apparent increase in measured tube wall thickness versus the intact base metal. A detailed assessment of the corrosion process determined that the base metal material, while subject to this unique corrosion mechanism, was the best alloy choice for this service.

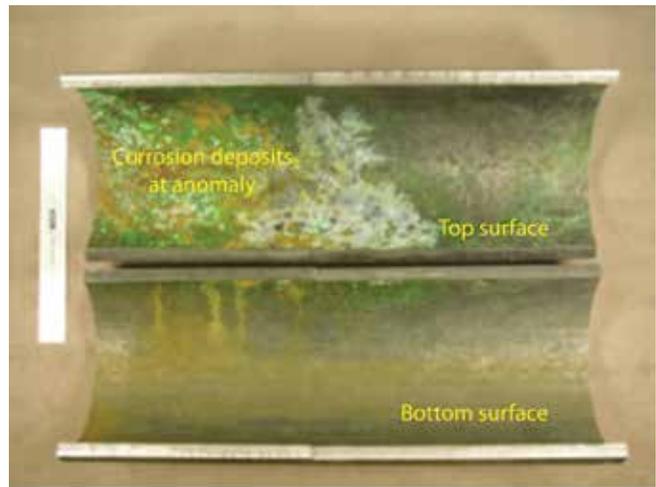
Figure 3. View of top and bottom interior surfaces of the tube

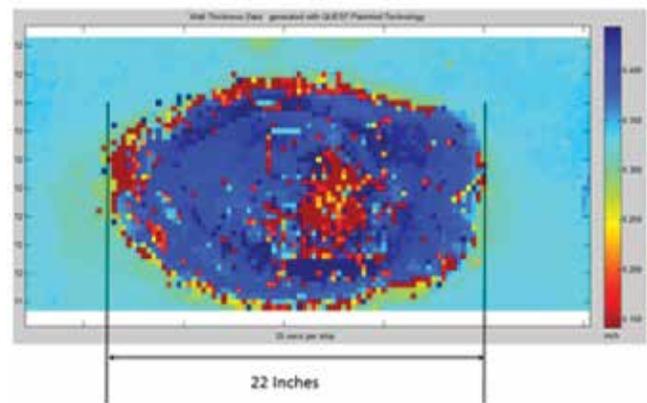
One year later a follow-up FTIS inspection was conducted with results similar to those in the previous FTIS inspection. Additionally, while the exact wall thickness could not be determined due to the previously described metallurgical changes, it was determined that in several locations the size of the affected area increased, thus indicating a continuation of the corrosion process (see Figures 4 and 5).

Figure 4. Initial inspection results showing anomaly

Future plans include annual monitoring of these areas with the FTIS technology until the client determines the unit is no longer fit for service and schedules coil replacement.

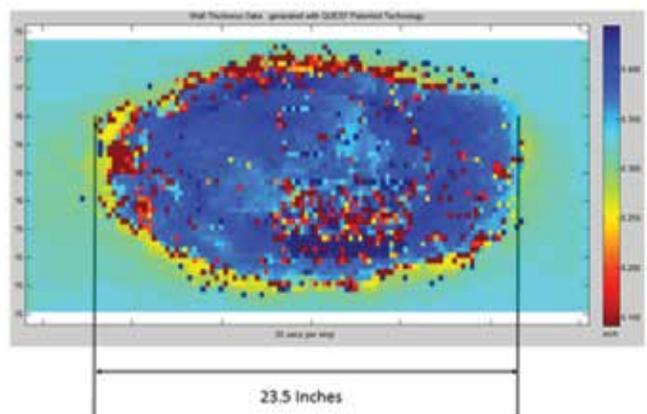
Figure 5. Second inspection (one year later) results showing anomaly
