CASE STUDY

REMOTE DIGITAL VIDEO INSPECTION (RDVI™) CASE STUDIES

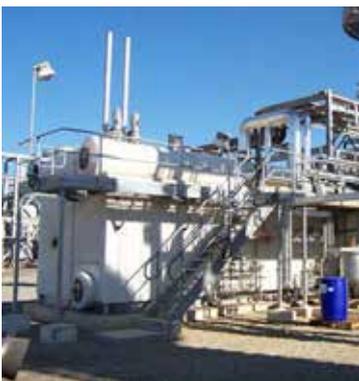
WATERTUBE BOILER

During a water tube boiler inspection, large amounts of deposition were found to be present throughout the unit. Fortunately this deposition was detected before serious corrosion and degradation had occurred. The risks of high deposition levels to asset reliability, efficiency, emission levels and life-span were discussed with the client. This information prompted modified boiler operation and enhancements to the water treatment programme.

This water tube boiler, along with other operational units, was scheduled for annual RDVI inspections as part of the plant maintenance and inspection schedule. Over the next three years the deposition was removed, resulting in no long-term damage. This process was completed without the application of expensive chemical cleaning.

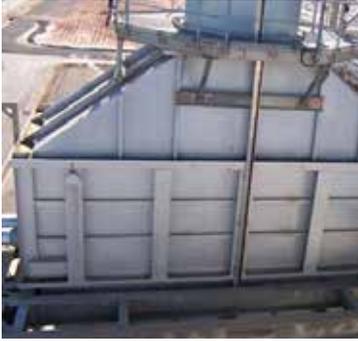
HRSG BOILERS

An inspection of an HRSG waste heat boiler revealed heavy deposition build up, flow assisted corrosion and areas of isolated corrosion. No indications of water or steam borne material had previously been detected in the water treatment testing. Due to the extent of the flow assisted corrosion and isolated corrosion, many tubes were required to be replaced. HRSG boilers are of a “cut your way in and weld your way out” construction making them expensive to repair.

With the results of the inspection highlighting the deposition and corrosion, the client altered the flow rates and velocities inside the unit and implemented tighter water operational parameters for makeup water and condensate return to suit the unique characteristics of their HRSG units.

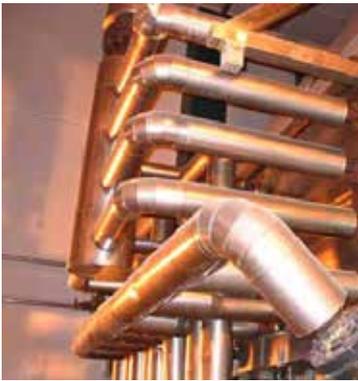
CONDENSATE RETURN SYSTEMS

The inspection of a condensate return system that was fed from seven different plants revealed the presence of two types of corrosion and excessive deposition levels. Chemicals used in the respective plants had been entering the condensate system as well as product material. This resulted in premature replacement of the condensate line, which required seven plants to shut down and caused extensive production losses during a peak production season.

Regular inspection of this line prior to leak detection would have detected minor corrosion and identified the source of the problem, providing the client with information to complete early remedial work and extending the system’s life for many years.

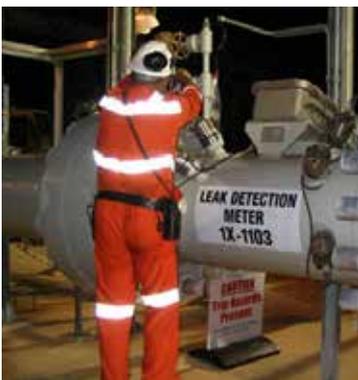
PRESSURE PIPING

A series of high pressure piping systems were inspected from a well head through and beyond a process plant. A series of camera systems were used to ensure accurate results. Approximately 95% of the entire process piping was covered from strategically located access points.

The client commented that the high level of coverage and subsequent results provided them with a high level of confidence regarding the condition of the plant, and putting it back into service. These results enabled the client to better target other NDT techniques to specific areas where indications or corrosion/erosion had been noted so that future remedial work could be scheduled.

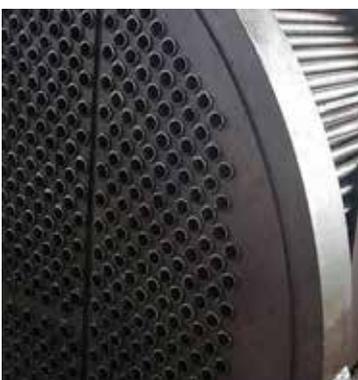
HEAT EXCHANGERS

Tube side – RDVI inspection determined that all except one of the units were free from deposits and other issues relating to the integrity and efficiency of the tube bundle. For the one tube bundle that required further cleaning, the head was removed, the tubes cleaned and re-inspected to ascertain the effectiveness of the clean, and the head re-instated.

Shell side – RDVI inspection determined the internal condition of the vessel and tube bundle without removal of the bundle.

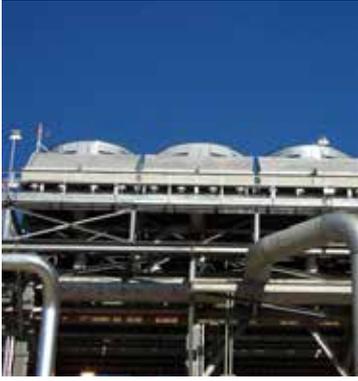
FIN FANS

RDVI techniques were utilised to inspect a series of fin fan units that contained varying levels of deposition. These units were then cleaned and an IRIS inspection was performed which detected some large pitting in some areas. The client requested we re-inspect the cleaned tubes using RDVI. Our inspection of the areas of pitting indicated by the IRIS tests found some deposition remaining and no pitting. Further cleaning and RDVI was undertaken. We were able to positively prove that there was no pitting in the tubes and show that the IRIS was unable to differentiate deposition and pitting.

This saved the client the cost of re-tubing a set of fin fans unnecessarily. The RDVI inspection was more time-efficient and had a higher level of accuracy in detecting deposits that are commonly found in these units. This inspection showed that previous cleaning was not up to standard, revealing that further cleaning was required to reach optimum efficiency.

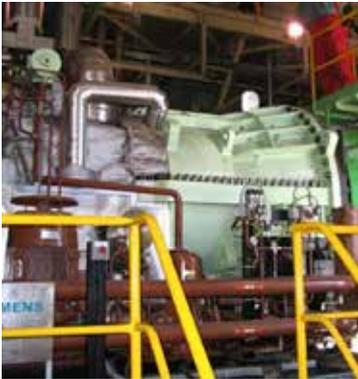
GAS TURBINES

A 10Mw gas turbine was inspected following our gas turbine inspection procedures. The second stage blades in the hot section were found to be severely damaged. The damage was consistent with heat/flame damage, however this would not typically occur in this area of a gas turbine.

Discussions with the client revealed that the unit had been run on a mixture of gas fuel and liquid fuel for a period of time. This explained the longer than designed flame path and the excessive heat in the second stage area.

The turbine was stripped down and the damaged blades and nozzles replaced. As we were able to identify the root cause of the problem, the client was able to modify his gas feed system to prevent liquids from being burned in a turbine that was not designed for liquid fuels.

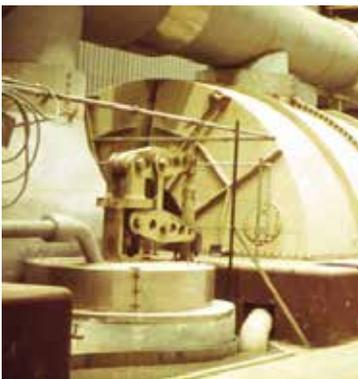
STEAM TURBINES

A client with a 25Mw steam turbine had noticed decreased performance and suspected there was some fouling of the blades. Production constraints and supply contracts presented significant challenges regarding off-line time. The typical cool-down period required for our normal RDVI inspection was not desirable.

The turbine was inspected using our umbilical heat exchanger (cooling jacket). The unit was still reading 240° Celsius at the time of the inspection. We detected fouling on the LP side of the Stage 2 blades along with indications of deposition passing through the HP gland seal system. This continued build up of these deposits and the premature wear they create on gland seal systems would have resulted in further decreased performance and more extensive repairs. Early detection proved to be invaluable to the client.

This inspection enabled the client to plan an outage at a more appropriate time in order to replace the blades and repair the gland seal system. The source of the fouling was also traced and the root cause of the problem solved. This unit was only off-line for approximately eight hours as opposed to the normal 48 hours plus.

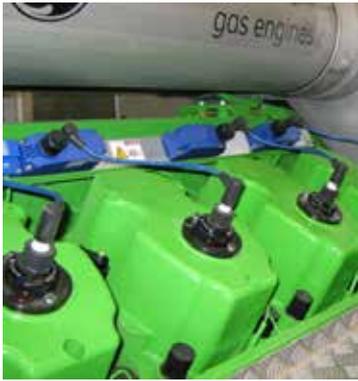
ENGINES

The inspection revealed early indications of the exhaust valve seat burning. This information prompted the client to instigate replacement valves immediately and better tune the air/fuel ratio to prevent further damage to other cylinder heads. The client was delighted that the findings had saved the need for a full head reconditioning.

Traditional compression testing would not have detected these early indications and would only have detected the issue with the valve, upon failure. Our RDVI procedure detected this prior to failure, saving money and time. These engines are now inspected at the regular service schedule using RDVI and subsequent head reconditioning has been fully eliminated outside of engine rebuild schedules.

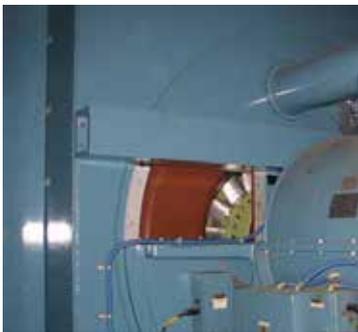
GENERATORS

Inspection of a generator used in the geothermal industry revealed a particular type of corrosion associated with hydrogen sulphide. Early detection enabled the client to install filter/scrubber systems on the generator's cooling ducts. As we were able to fully ascertain the extent of the corrosion, the client also organised a replacement unit to be built and installed at a later date.

With early detection the client was spared the costs of product losses. The inspection for this type of generator typically takes about three hours which minimises the time the unit is required to be off line. The client elected to monitor the generator and conduct bi-annual inspections.

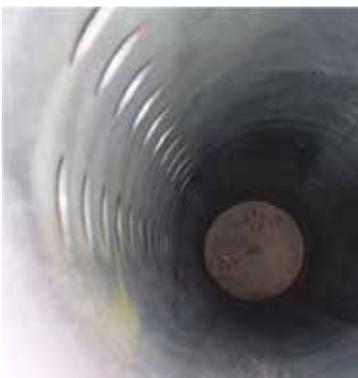
HEADERS

Inspection of a steam header with multiple tube penetrations detected a ligament type cracking between the tube penetrations. The approximate length and depth of the cracks were determined and this information shared with engineers and metallurgists. The plant was put back into service but with very short inspection intervals. The inspection procedure was changed from an In-Service type to a "Condition Monitoring" inspection to minimise down time and enable the level and rate of degradation to be ascertained more efficiently.

These headers were re-inspected on a regular basis using a custom made camera tool and our condition monitoring procedure. The inspections were completed efficiently with minimal disruption to production levels. The changes in the crack indications were monitored and checked against minimum material levels. This gave the client time to instigate permanent repair or replacement of the headers and continue production without incurring substantial production losses.

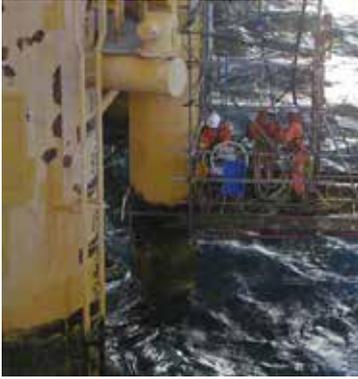
SEA WATER CASIONS/PUMPS

The inspection of a seawater lift pump and discharge casing provided information on the following:

- the condition of the internal protective coating
- the amount of bio-fouling occurring
- the condition of corrosion control anodes inside the casing and directly below the inlet
- any issues inside the pump regarding the shaft supports, bearings and impellers.

This inspection was completed with minimal disruption to the availability of the pump for process operation, and did not cause any loss of production. From the information gathered the client was able to determine that no remedial action was required. The inspection procedure and results were then entered into the clients RBI system.

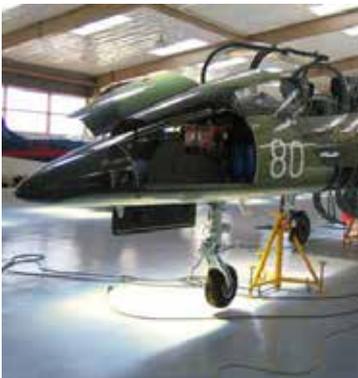
AIRCRAFT

An aircraft was set for a scheduled inspection. This aircraft had a number of operational issues associated with its working environment. The very windy airport was adjacent to the sea, and the craft did high altitude work adjacent to a ski field.

Upon inspection we noted degradation to the engine from salt ingestion. The information gathered from this inspection placed the engine on 50 hour service intervals until the engine could be replaced. It also resulted in the engine manufacturer changing the coating on the blades in the hot section and the material used in the compressor section of the engine to one more suited to the aircraft's operational environment. The client was able to continue to operate his aircraft with minimal disruption until a new and more suitable engine arrived from the manufacturer.

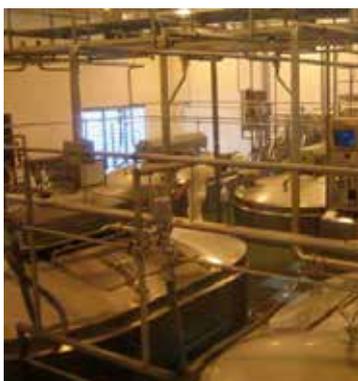
BACTERIAL TRACK AND TRACE

RDVI methods were employed to inspect a food processing facility with high APCs, product contamination issues, higher CIP costs and reduced plant availability for production.

Two issues occurring within the piping systems were identified. The first was ineffective CIP performance in some isolated areas of the system due to piping design/installation. The second was a series of weld structures with defects that harboured bacteria which were not able to be removed during the cleaning process.

All the defective welds were tagged for removal and the areas of piping that were not being cleaned effectively were re-routed. This resulted in a significant 50% increase in production times before a CIP cycle was required. It also reduced the issues associated with product quality enabling the client to sell his product for higher rates.

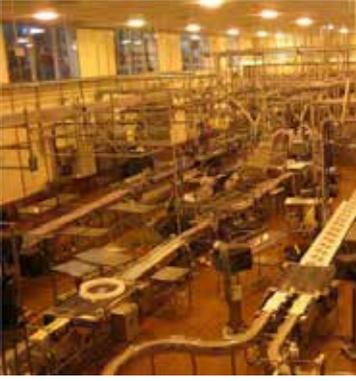
QA AND QC

A series of weld seams had been inspected by torch and mirror, and radiography in a sterile food process system. The client was concerned with the disruption of work during radiography and the limitations of the torch and mirror method.

The Sterile Welding ITP was used as it targets the defects known to cause issues with bacterial and quality control. A series of weld structures that would harbour bacteria and be unable to be cleaned effectively using traditional CIP methods was identified. RDVI was able to reach well beyond the torch and mirror limitations and identified weld formations that had been passed by radiography but were actually formations that harbour bacteria and cannot be effectively cleaned.

The client concluded that our inspections were more suitable than previous techniques they had employed. RDVI methods enabled access to areas required, provided a high level of definition/accuracy that could not be achieved with radiography, reduced disruption time and increased the coverage per day. This resulted in savings of 75% compared with previous methods. It also ensured that their operational system could be maintained as a sterile environment as required. Results of this inspection were used to further up-skill the welding crews to enable a more consistent defect free welding process.

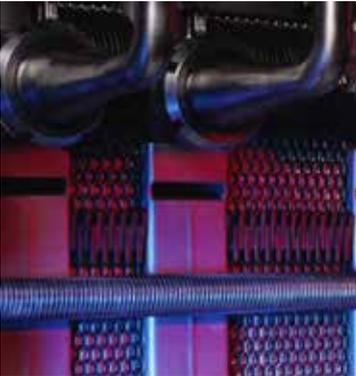
CIP EVALUATION

A client requested RDVI inspection to provide information on the effectiveness of a CIP process, which was currently experiencing some issues.

The inspection revealed that the CIP process was not effectively cleaning the system. Product residue, solids and fats were noted in the system with what appeared to be a bio film present in 40% of the process piping. Sections of the piping were replaced and some modifications were made to the CIP system. The results of the inspection pinpointed the exact locations where the CIP process was not performing correctly and subsequent modifications were made to the plant.

This enabled the client to reduce his effective CIP cycle and target a process that was more effective for the type of product being manufactured. It also provided him with longer production times and reduced effluent discharge, chemical and energy use. The product quality was increased providing a longer shelf life.

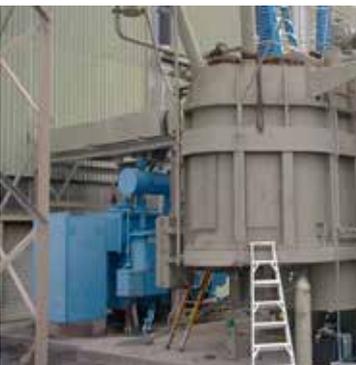
TRANSFORMERS

A client wanted to use RDVI techniques in an electrical transformer to see if we could remove a foreign object dropped in the unit. The object was successfully located and removed. Further inspection of the unit revealed serious degradation to the insulation and showed that many of the internal packers had loosened, with some falling to the bottom of the unit.

The load on this unit was lowered to prevent a catastrophic failure and the client was able to plan and arrange for a replacement unit. This inspection showed the ability of RDVI techniques to detect problems that cannot be detected with traditional testing. As a result of the inspection outcome, the client implemented regular RDVI inspections to ensure prevention of premature failures in similar units.

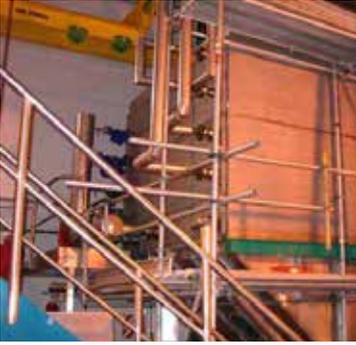
AIR HEATERS

A client's air heater units for air drying operations were cracking causing steam and associated chemicals to contaminate the food product being processed. RDVI inspection revealed a number of issues with the method in which the tube penetrations were mounted in the header and the quality of the welds.

As a result of the inspection, the entire air heater was set to be replaced and a warranty claim was lodged with the manufacturer. The inspection information was also used in a redesign of the units. All new units for this client are now inspected by using RDVI techniques to ensure that the joint type is correct and internal weld profile is uniform to prevent stress points, cracking and corrosion. Quest Integrity RDVI have developed a specific ITP for these units and a set of standards for the internal weld seam profile that is now used extensively in these units.

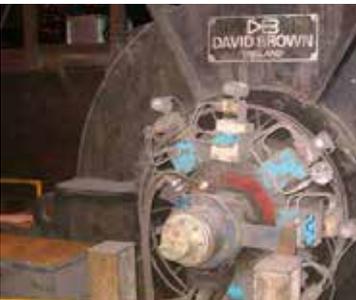
ELECTRIC MOTORS

RDVI was used to inspect a large electric drive motor that had got wet. The inspection revealed corona was present in and around the windings in the motor. The inspection also detected a number of other issues associated with the condition of the windings, supports, insulation and deposition.

With the results of this inspection the client was able to plan a suitable time to complete the repairs and reorganise plant operation to reduce the loads on the motor. The client requested our inspection programme to be implemented across all their electric motors as part of their maintenance schedule.

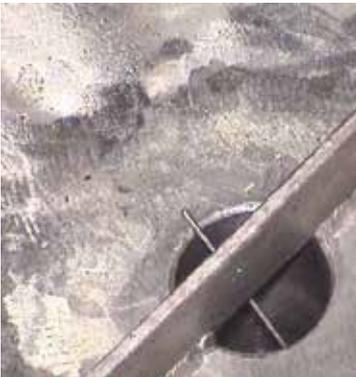
DEBRIS RETRIEVAL

A client suspected that a series of recent plant trips may be associated with a particular pressure vessel. RDVI was chosen early on in the fault finding process to help determine the cause.

The most time-efficient method of inspection was requested as the plant would be down in a critical production area. The inspection revealed debris blocking the discharge nozzle in the bottom of the vessel. The client was concerned that a confined space entry was required to remove the debris. A confined space entry would require further isolation, venting and purging and would cause further delays in getting the plant restarted.

Using our specialist RDVI retrieval tools, we were able to remove all the debris causing the obstruction, eliminating the need for a confined space entry. The vessel was closed up and plant restarted immediately. This is a technique we deploy regularly to remove foreign debris from process plant and also with steam turbine clean out and re-assembly procedures.

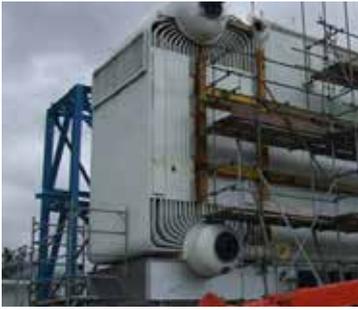
STEAM TRANSPORT SYSTEMS

A main steam feed line connected to eight different process plants was inspected. Inspection revealed isolated areas of corrosion in the steam lines. The client was able to investigate and determine that the root cause of the corrosion was a chemical used in the steam generation process. A chemical substitute was found and used.

The client was able to target other NDT techniques in areas where we noted corrosion to ascertain minimum wall thickness levels and complete remedial work as necessary.

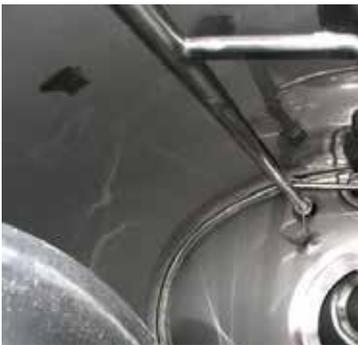
TANKERS

An RDVI inspection of milk tanker bodies revealed two major issues affecting a number of tanker bodies – a particular type of spray ball was not effectively cleaning the tankers, and there was loose internal piping beginning to damage the internal surfaces of the tanker.

The client was able to temporarily remove these tanker bodies from service whilst keeping those with correct spray ball systems and pipe fastenings in service. The loose piping was able to be repaired easily as early detection did not allow for extensive damage to occur.

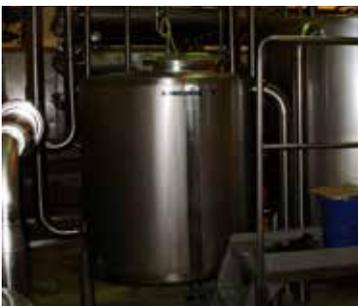
SILOS/TANKS/CYCLONES

A series of balance tanks, silos and cyclones were inspected as part of an annual survey. We were able to determine that a number of units were not cleaning correctly. Comparison of these results with the results from previous inspections revealed that several units were developing a “bloom”.

The client was able to replace defective spray balls and modify the CIP process to ensure the unit was cleaned to a more satisfactory standard. They were also able to produce product with a more consistent quality and eliminate costly product down grades.

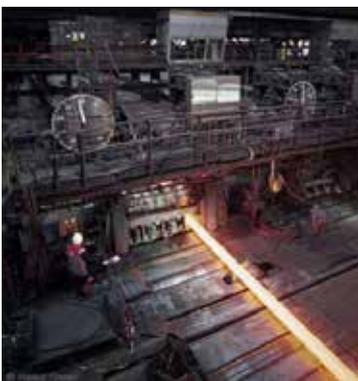
COOLING WATER SYSTEMS

A cooling water jacket system in a steel rolling mill was inspected. A large amount of deposition, tuberculation and indications of under-deposit corrosion were found in the system. This was reported to the client who dismissed the initial findings and our draft report. We returned to our office and compiled the finished report with an extract from technical journals on the type of corrosion and formations we had noted. The client read our finished report and began to arrange for the entire system to be re-built.

The client confirmed that the information we had provided at the end of the inspection was true and correct. He also stated that if the inspections had been undertaken earlier, the initial indications would have been identified and, through altering operational processes, prevented the premature degradation and replacement of the system.
