# **Engineering Assessment of Deformed Spillway Gate**

David Osuna, Consulting Engineer<sup>1</sup>

<sup>1</sup>Quest Integrity NZL LTD, 69 Gracefield Rd, Lower Hutt 5010, New Zealand

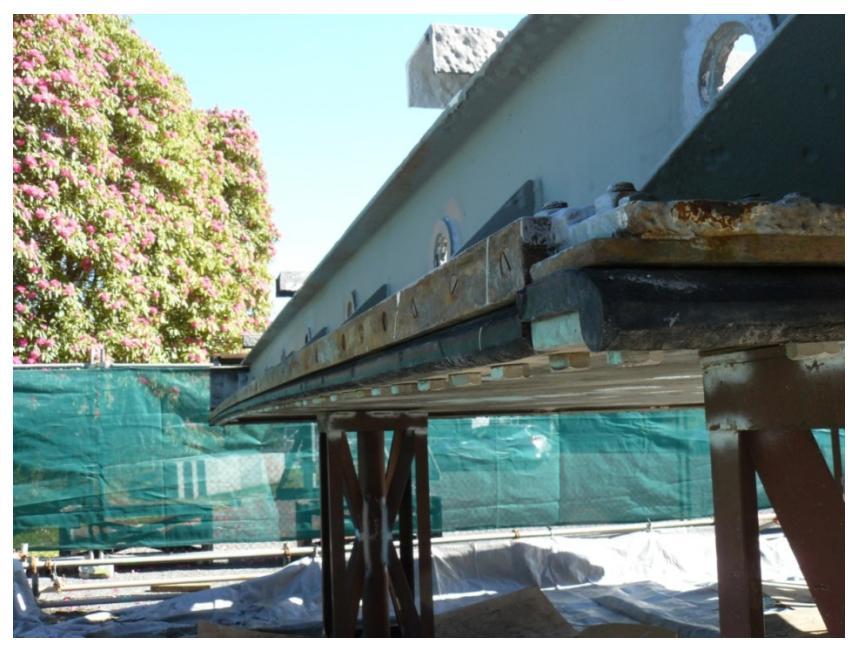
Late in 2014 Gate 2 was removed from service for installation of bird netting. After removing the gate, it was found that the lower section had undergone permanent deformation as seen in Figure 1. Corrosion on the internal and external surface of the spillway gate was also reported as seen on Figure 2. A fitness-for-service assessment of the current condition of the spillway gate was therefore carried out.

Figure 1. Deflection at the bottom of spillway gate No. 2

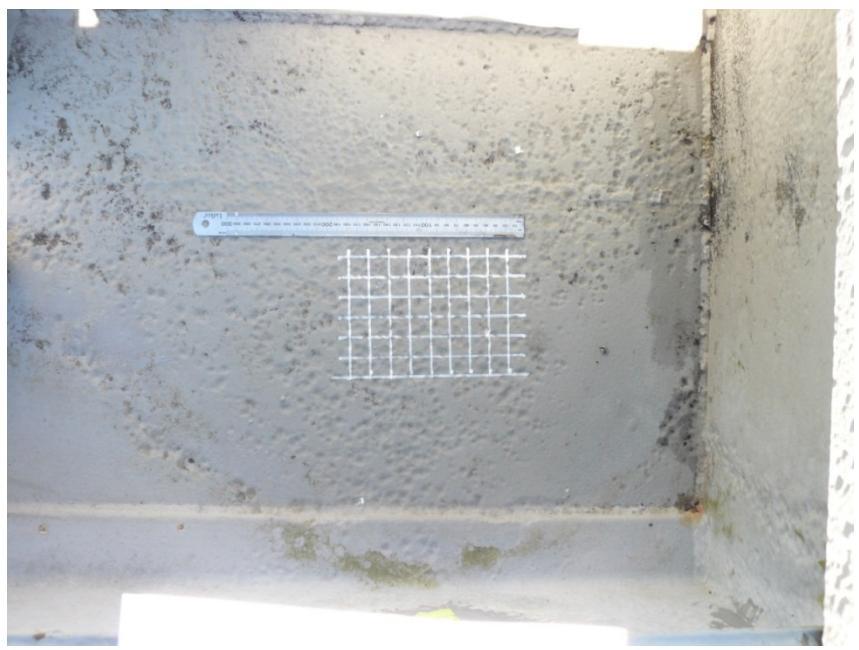
Figure 2. Surface corrosion in between lower girders A3 and A2

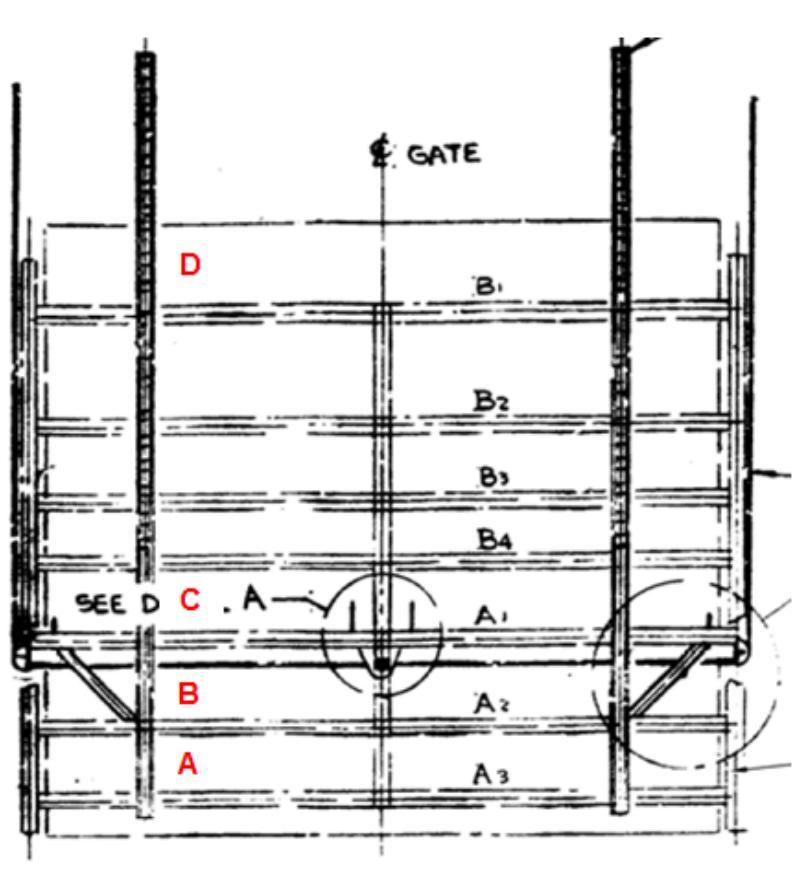
Figure 3. Location of thickness measurements readings

Location A showed the highest level of metal loss with respect to the nominal thickness of 15.875 mm. On the other hand, location D showed minimum metal loss with a value very close to the skinplate nominal thickness. It was found that the metal loss magnitude was related to the location of the skinplate section with respect to the spillway gate height. The bottom sections showed higher degrees of metal loss compared to the top sections.

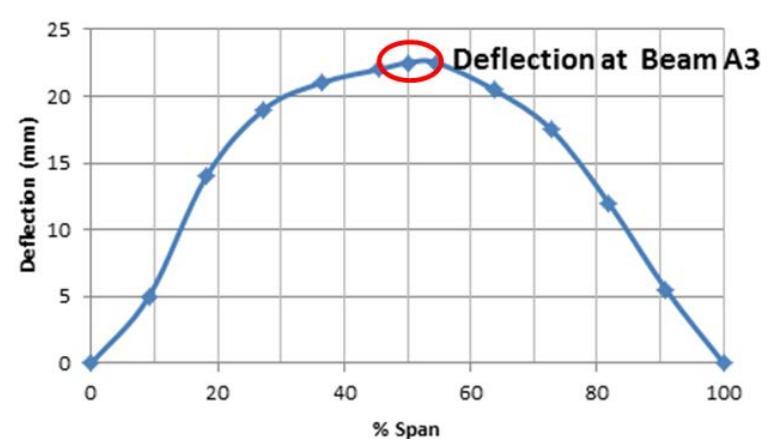
The deformed model was generated based on the deflection reported by Mighty River Power at girders A3 and A4 as seen in Figure 5 and Figure 6. Only the maximum deflection point at each girder was considered to generate the deformed shape. With respect to the superficial corrosion, it was modelled by modifying the thickness of the skinplate section.

Figure 5. Measured deflection at Beam A3. Maximum deflection point is highlighted.

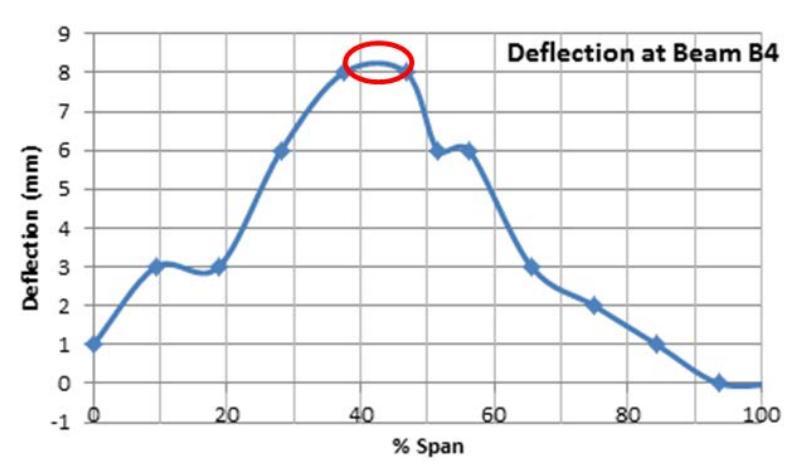
Figure 6. Measured deflection at Beam B4. Maximum deflection point is highlighted.

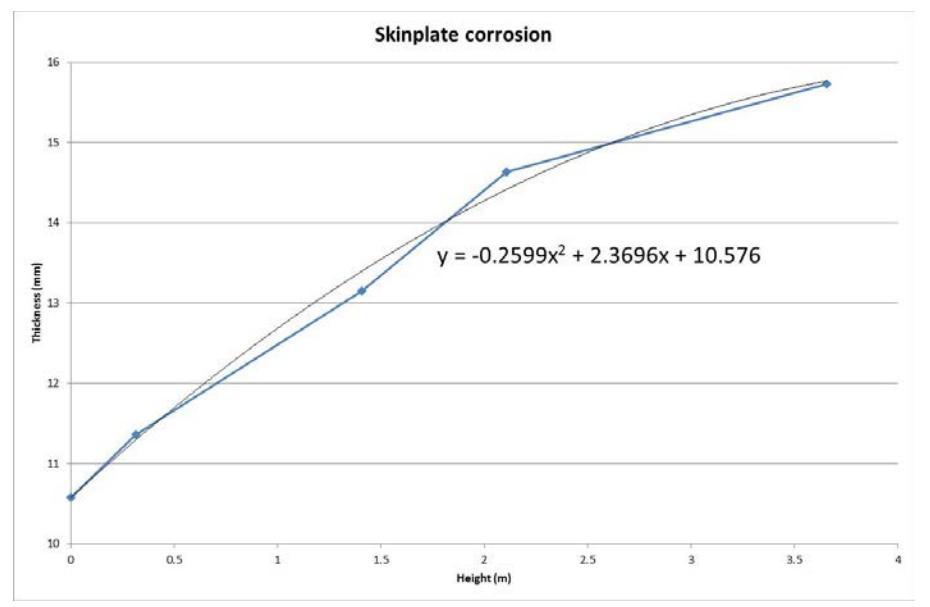
A function for the thickness with respect to the height of the skinplate was developed based on the on-site readings as shown in Figure 7. The height dependant function developed did not account for localised metal loss along the span of the plate; sections at the same height were considered to have the same thickness.

Figure 7. Analytical function used to model the superficial corrosion on the skinplate. The height-axis origin was considered to be the bottom of the spillway gate.

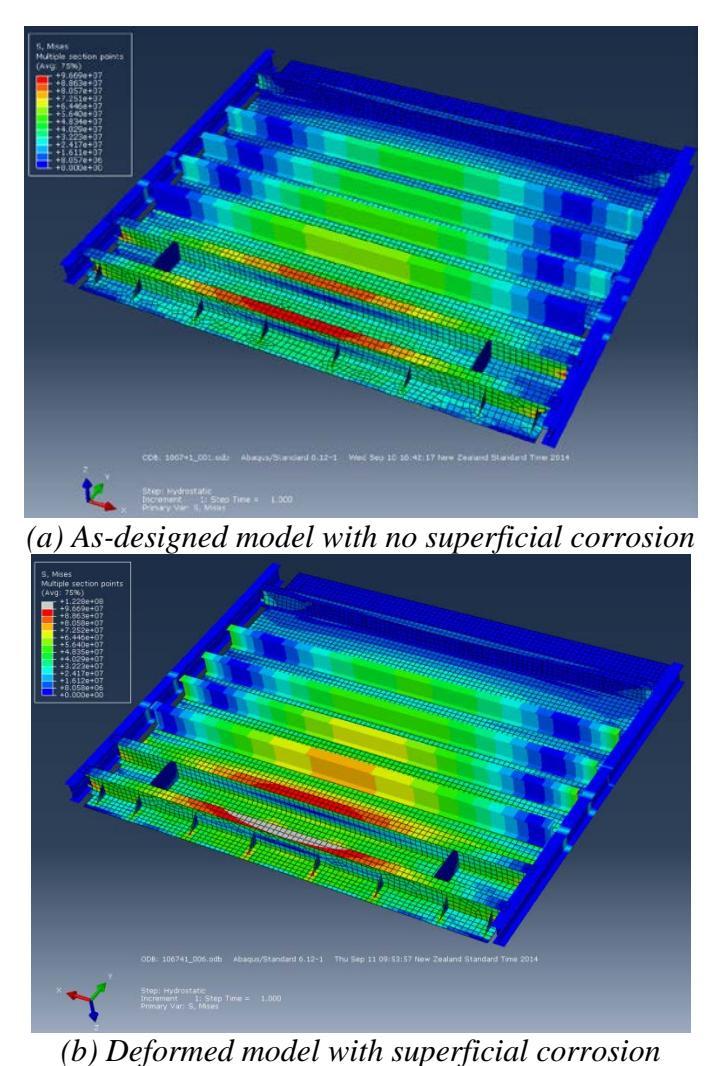
Stress results were obtained for the two different scenarios considered as described in section 3. As the hydrostatic load is highest at the bottom of the spillway gate, the highest level of stresses is seen at the bottom of the spillway gate. The locations that exhibit the highest levels of tensile stresses are the top plates of the two bottom I-beams. As seen in Figure 11, the deformed model with superficial corrosion undergoes a higher level of stresses, especially at the centre of the top plate of beam A3.

Figure 11: Von Mises stress distribution under maximum operating loading conditions. Stresses in Pa.

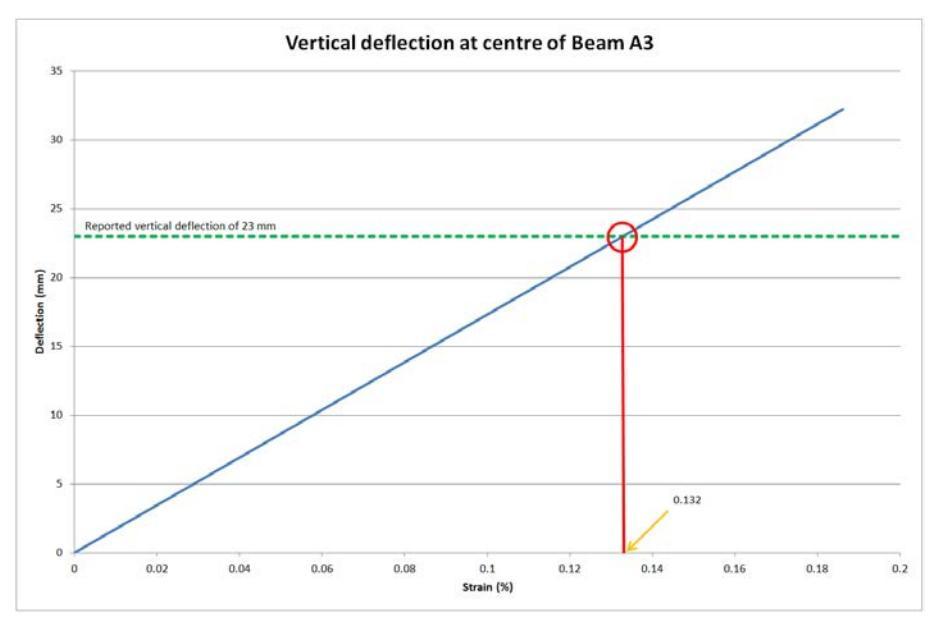
As seen in Figure 13, a strain of 0.13% is required to cause a vertical deformation of 23 mm at the centre of beam A3.

Figure 13. Vertical deflection as a function of strain. As-designed model.

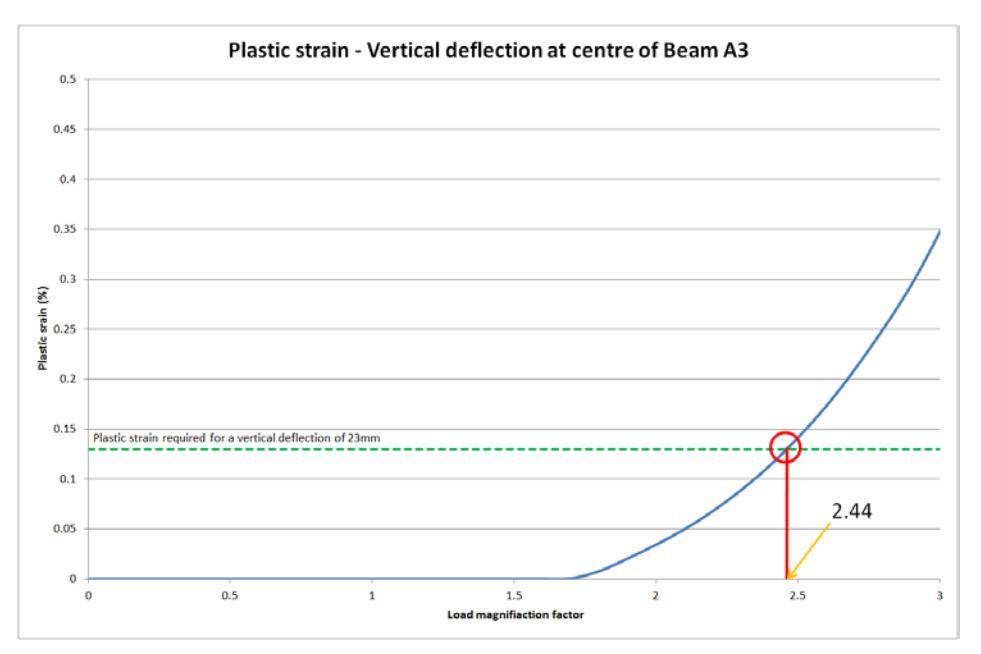
For the purposes of the deformation load estimation, a load magnification factor was applied to the maximum operating load to include hydrostatic loads as big as 10 times the maximum operating load. As seen on Figure 14, to generate the plastic strain required for a vertical deflection of 23mm, a load 2.4 times the maximum operating load is required.

Figure 14. Plastic strain as a function of load magnification factor. As-designed model.

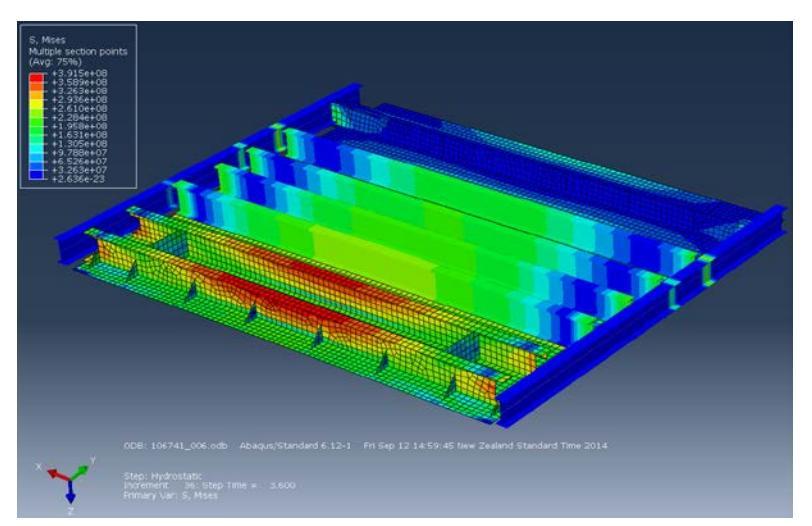
As seen on Figure 15, the as-deformed model of the spillway gate subjected to a load factor of 3.6 reached a converged solution. Therefore, the as-deformed model with corrosion damage satisfied the global criteria for protection against plastic collapse under the guidelines of Annex B of ASME FFS-1.

Figure 15. Von Mises distribution of the converged solution for a 3.6 load factor. Stresses in Pa.

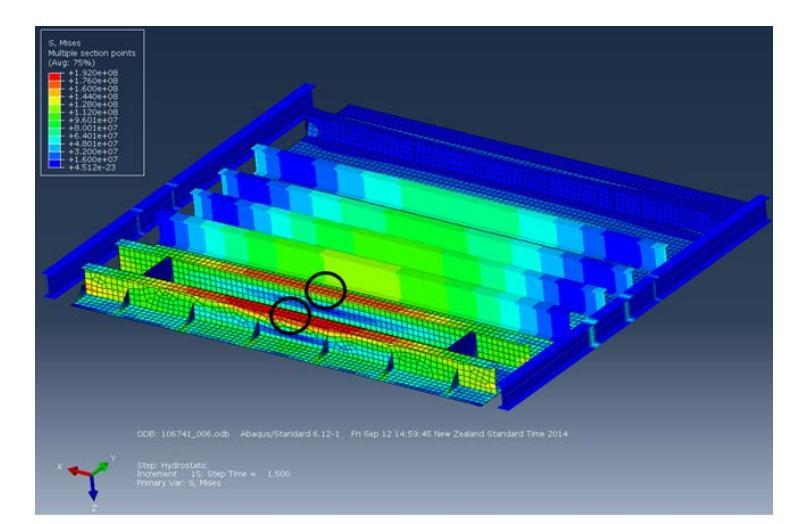
In accordance with the local failure criteria guidelines of ASME FFS-1, the model that included the permanent deformation and surface corrosion is required to satisfy the failure criterion against the applied loading condition with a load factor of 1.5. High stressed locations were identified for the assessment and assessed as seen in Figure 16 for that particular loading scenario.

Figure 16. Von Mises stress distribution. Load factor of 1.5. The two locations assessed for local failure are indicated. Stresses in Pa.

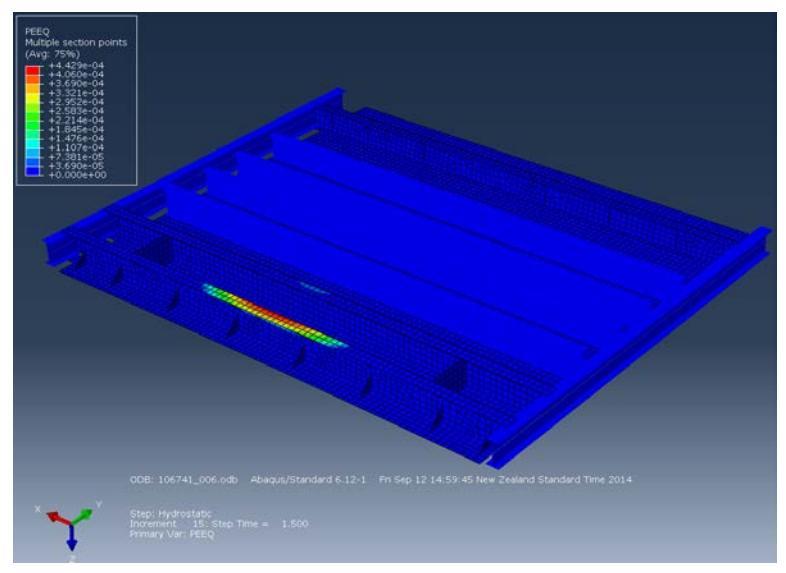
For the component to satisfy the local failure criterion, the total equivalent plastic strain ( $\varepsilon_{peq}$ ) must be less than the limiting triaxial strain ( $\varepsilon_L$ ). The total equivalent plastic strain at the assessed locations is extracted from the results of the elastic-plastic analysis with the load factor of 1.5. A distribution of the total equivalent plastic strain is shown in Figure 17.

Figure 17. Equivalent plastic strain. Load factor of 1.5.

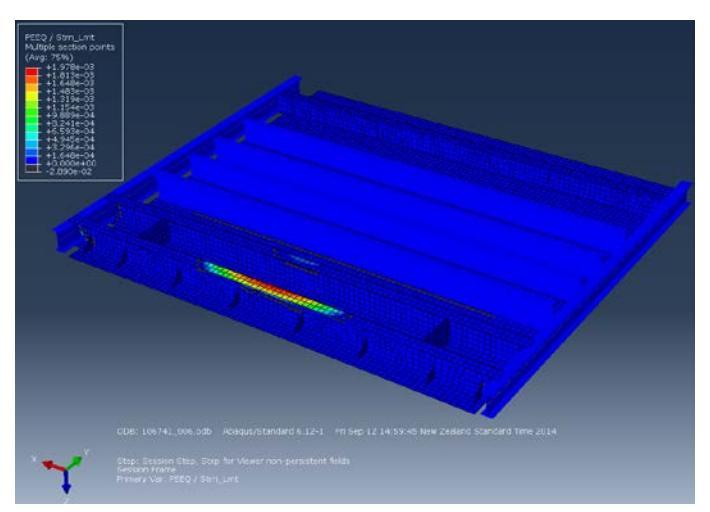
Figure 18 shows a plot of the criticality of locations for the local failure criterion by displaying the total equivalent plastic strain – triaxial strain limit ratio. As all the areas show a ratio below 1, it is considered that the spillway gate satisfies the local failure criterion. However, it was determined that under the current levels of deformation and metal loss, the most critical location corresponds to the top plate at the centre of beam A3.

Figure 18. Plot of the Eq. Plastic strain – Triaxial strain limit ratio. Load factor of 1.5.
