Continual Fired Heater Inspections Reveal Mystery Damage Mechanism

Quest Integrity was requested to perform consecutive inspections on a single atmospheric furnace unit. In 2014, the asset was inspected utilizing Quest Integrity's Furnace Tube Inspection System (FTIS™). Due to the severe extent and unknown cause of the damage, the findings were further verified visually using Remote Video Inspection (RVI). After the damaged piping was replaced, early indications of the same damage mechanism were detected in a subsequent inspection one year later.

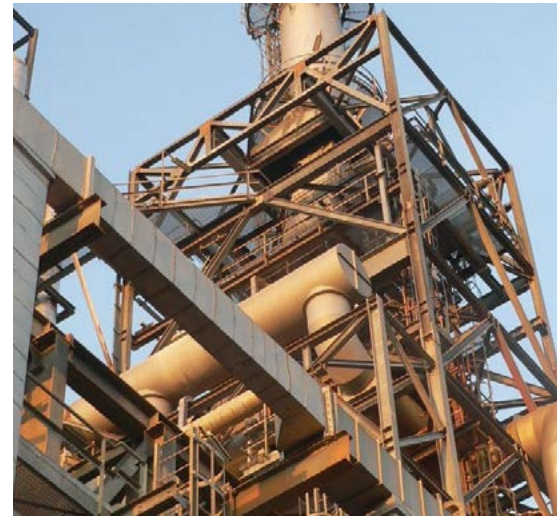
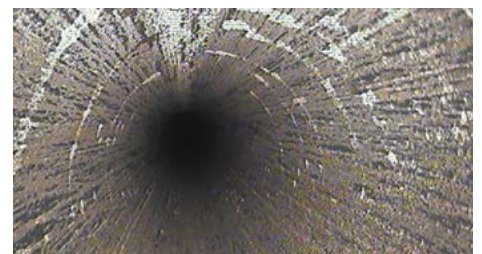
Using its Furnace Tube Inspection System (FTIS™), Quest Integrity performed an inspection and assessment on 100% overlapping coverage of the tubing in both the radiant and convection sections of the fired heater. The results of the 2014 inspection revealed an unknown damage mechanism causing significant wall loss in the convection section of the piping. After the initial FTIS™ inspection, the client utilized Quest Integrity's Remote Video Inspection (RVI) in order to visually verify the furnace tubes with the most severe internal wall loss. The Convection box was opened and return bend elbows were removed to allow boroscope access to the damaged areas of piping. This visual inspection provided additional imaging of the unknown damage mechanism as shown in Figure 1. The use of the RVI and FTIS™ inspection methodologies ultimately allowed the client to have both visual and UT radius and wall thickness data of the damaged unit.

Figure 1. RVI visual images show the extent of the damage within the convection section of the piping.

Based upon the 2014 inspection findings, the client replaced the damaged tubes within the convection section of the heater. A follow-up FTIS™ inspection in 2015 revealed internal wall loss with the identical pattern and location, as seen in the 2014 inspection.

Considering the rapid acceleration of the wall loss within only a few months of operation, the damage was considered extensive. Based upon the inspection findings in 2014 and 2015, the client ultimately replaced the entire convection box with tubes of a different metallurgy in order to avoid encountering the same accelerated metal loss in the future.

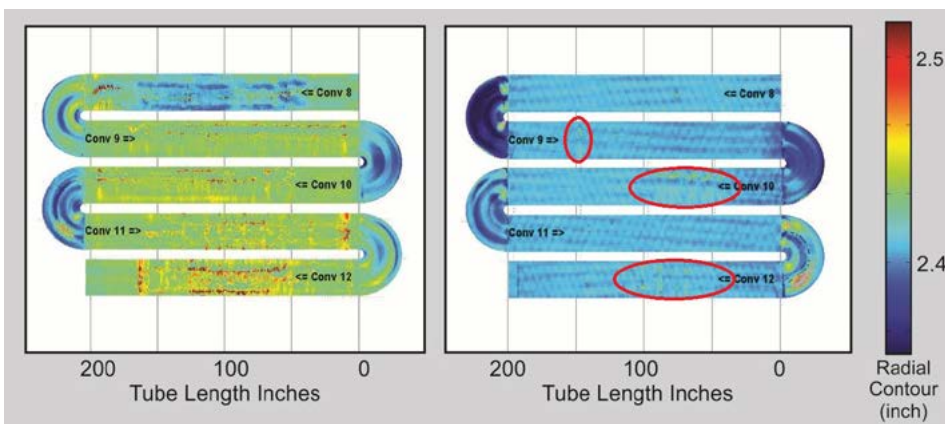
Figure 2: Internal Radius reading from the 2014 (left) and 2015 (right) inspections show different values (due to tube replacement after 2014 inspection), but with identical emerging patterns of damage within this section of convection piping.
