WHITE PAPER

DO YOU KNOW THE USEFUL REMAINING LIFE OF YOUR CRITICAL WATERWAY AND GENERATOR COMPONENTS?

ON AVERAGE, U.S. HYDROPOWER PLANTS ARE 64 YEARS OLD^[1]. HAVE YOU CONSIDERED THE CONDITION OF YOUR FIXED AND ROTATING STEEL COMPONENTS?

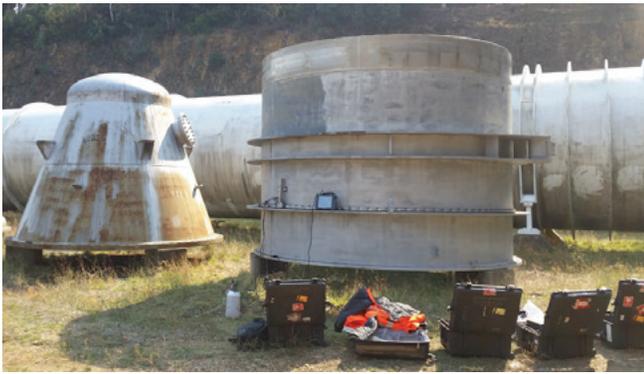
Figure 7: Removed section of penstock used for ToFD calibration.

As part of this project, an on-site advanced ultrasonic inspection of the three penstocks was performed at predetermined locations of peak stress. Time of flight diffraction (ToFD), which uses the time for which an ultrasonic (UT) pulse takes from transmitter to receiver probe to determine position and size of a reflector (i.e. defect), was employed.

In order to ensure that the results were accurate and repeatable, a test calibration was conducted on a section of penstock that had been previously removed from service (see Figure 7).
