Choosing the Right Smart Pigging Technology: Lessons Learned

Knowing your provider's technical capabilities is vitally important for long-term fired heater optimization.

Overview

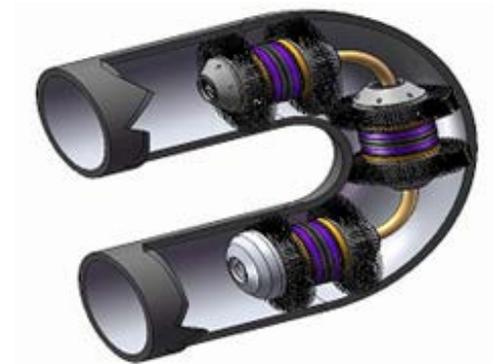
Figure 1. Smart Pig Navigating Piping

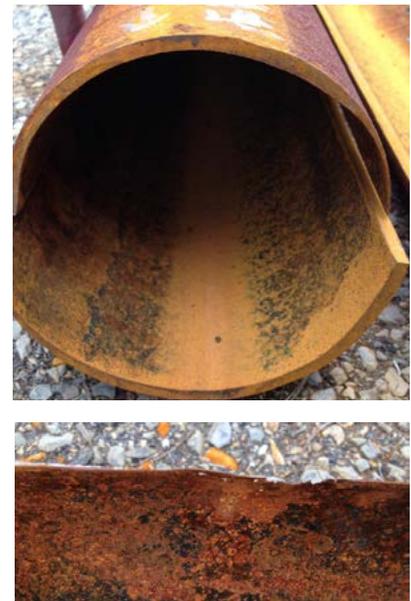
PBF Energy's Delaware City Refinery contacted Quest Integrity in May of 2016 to provide an emergency inspection on tubing coils in a reboiler heater using Quest Integrity's Furnace Tube Inspection System (FTISTM). A week prior, the unit had a small fire in the convection section from a tube that leaked. An examination of the failed tube identified localized sulfidation corrosion, which was not expected. To assess the condition of the remaining tubes in the convection section, PBF reached out to a global smart pigging company to perform an inspection. During the planning phase, the chief inspector for the refinery provided a tube replacement reporting threshold of 0.075 inches remaining wall thickness. The inspection was completed and the findings showed that no tubes were below 0.118 inch remaining wall, indicating that the coils were fit for service. During a subsequent coil hydrotest prior to returning the heater to service, another tube failed. An examination showed the same localized sulfidation corrosion as the cause.

Figure 2. Tube with sulfidation corrosion (cut open)
