# Cleaning, Inspection and Assessment of Steam Reformer Convection Coils Now Possible

To mitigate possible future tube failures and obtain much needed integrity data, a Methanol plant located in the Middle East contacted Quest Integrity to perform an FTIS™ (Furnace Tube Inspection System) smart pigging inspection (see Figure 1) and fitness-for-service screening assessment on 100 PNG Preheater coils. The coils had never been cleaned before and light internal fouling was suspected given the number of years in operation. As such, Quest Integrity was requested to clean the coils in addition to pumping the FTIS tool through the coils using its Advanced Mechanical Cleaning and Pumping Technology.

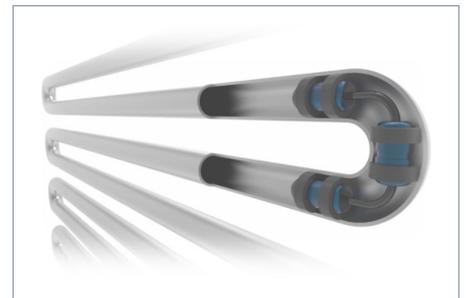
Figure 1. FTIS Smart Pig

ultrasonic in-line inspection technology that detects and measures damage such as internal and external corrosion, erosion, pitting and fretting as well as deformations such as bulging, swelling, denting and ovality in numerous coil configurations. This technique provides owner-operators with a complete and quantitative mapping of a coil's wall thickness and geometry. The inspection data from the FTIS service is then used along with heater design and operating parameters to conduct a LifeQuest fitness-for-service screening assessment following the API 579-1 Standard. This service provides owner-operators with the confidence that a furnace can be returned to service and safely operated until the next planned shutdown.

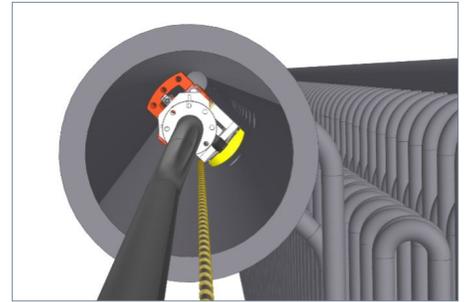
Figure 2. HDS Inside a Common Header

As with many steam reformers, common headers were attached to the inlet and outlet of each coil. This added to the complexity of the project, since the cleaning pigs and FTIS tool would need to travel through the header first for entry into the coils. For successful navigation through the heater, Quest Integrity's Header Delivery System (HDS) was installed inside the inlet and outlet common headers of each coil. The HDS effectively connected the coils via hoses to the water pumps installed on Quest Integrity's cleaning truck (see Figures 2 and 3). This created a closed loop system, allowing water to enter the coils to provide a couplant for the ultrasonic inspection while also propelling cleaning pigs and the FTIS tool through the coil via the cleaning truck pumps.

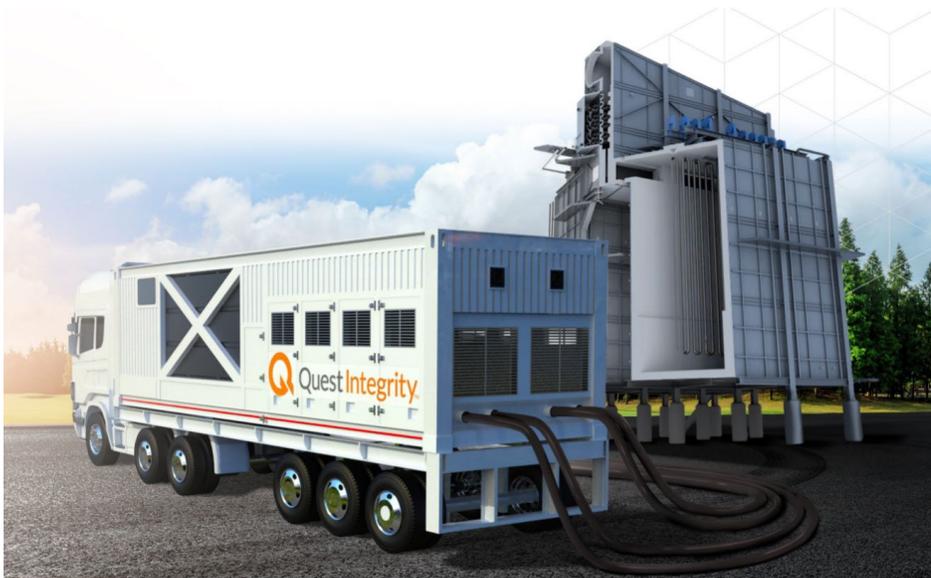
Figure 3. Set Up for Advanced Mechanical Cleaning and FTIS Inspection

Advanced Mechanical Cleaning uses state-of-the-art pumping trucks and mechanical cleaning pigs to effectively remove internal fouling from tube walls, restoring proper heat transfer and thermal efficiencies. FTIS is a high-resolution

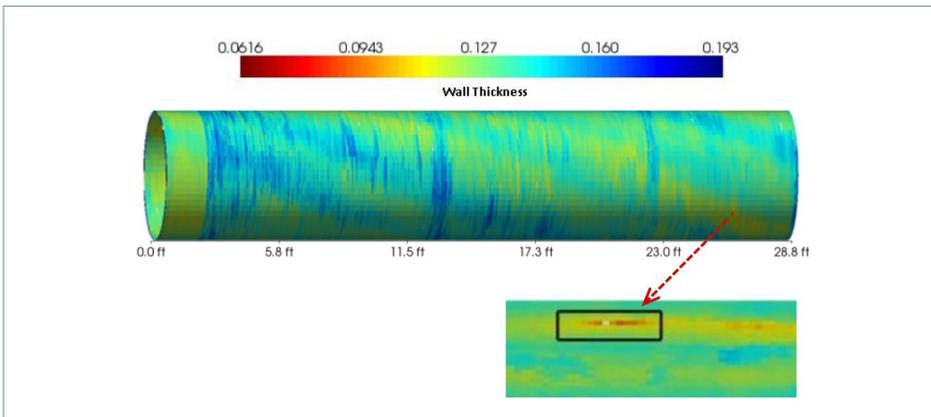
Figure 4. Wall Thickness Plot Showing Localized Wall Loss

The FTIS inspection revealed moderate internal and external localized wall loss upwards of 40 percent in numerous pipes (see Figure 4). General internal wall loss upwards to 26 percent was also present in the 180-degree return bends. The result of the engineering screening assessment showed that the coils were fit for service for the next four-year operating period. A remaining life assessment was also performed on each coil as part of the screening assessment, showing an estimated remaining life of 15 years with a recommendation to re-inspect in four years to monitor corrosion rates and detect any other localized damage that may affect coil integrity.

The FTIS technology provided valuable insights on the actual condition of the coils and the fitness-for-service screening assessment provided assurances that the coils could be safely operated for the next four-year operating period. The three services combined provided the plant with a highly effective approach to optimizing the performance and reliability of the PNG Preheater coils, minimizing downtime and maximizing production and furnace profitability.
