PVP2020-21581

ASSET INTEGRITY MANAGEMENT AND FITNESS-FOR-SERVICE ASSESSMENT OF A PIPE ELBOW WITH METAL LOSS

Greg Thorwald¹, Devon Brendecke
Quest Integrity
Boulder, CO

Stephen Webb
Metegrity Inc.
Edmonton, AB

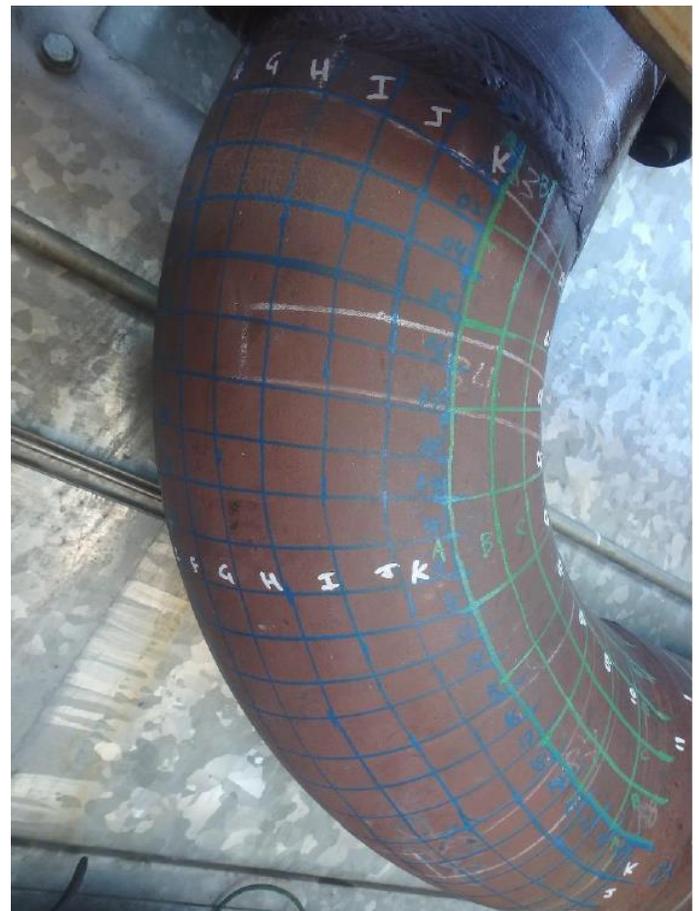
In order to complete the FFS assessment, a thickness grid was recommended. API 579 [4] provides guidance on the spacing between readings for a local metal loss assessment to ensure adequate readings based on the thickness and diameter of the component. An FFS/TML grid was created on the elbow and the UT thickness readings were uploaded from the datalogger and saved in the AIM software. The UT thickness were measured using the grid shown in Figure 3. The readings were initially downloaded from UT datalogger to the AIM quarantine for review and acceptance. The thickness readings were then sent to the AIM software for corrosion rate and remaining life calculations. The AIM software flagged readings that were below the calculated minimum thickness and identified that there was no remaining life for the grid, requiring further analysis.

FIGURE 3: ULTRASONIC THICKNESS READING ON GRID ACROSS ELBOW. READINGS USED IN FFS ASSESSMENT.

The UT inspection measured the elbow wall thickness using a 1 inch by 1 inch grid on the extrados (refer to Figure 3). The

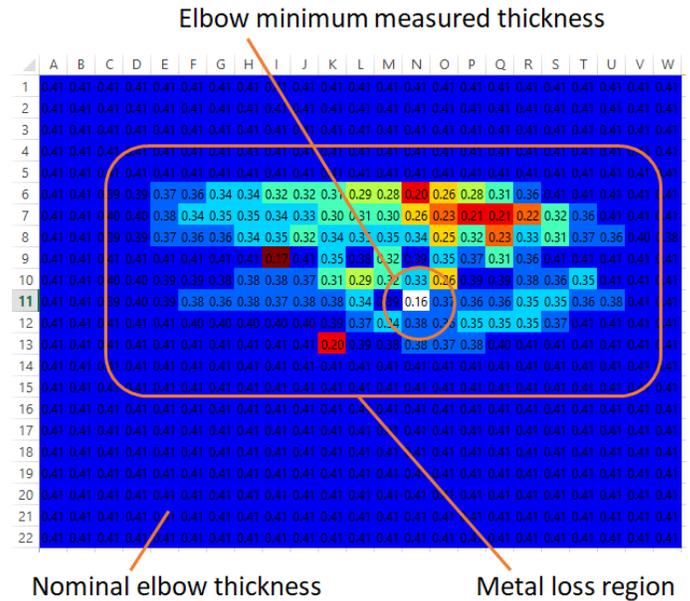
UT inspection grid on the intrados also had a 1-inch spacing around the circumferential direction, but had an approximately 2-inch grid spacing where it meets the extrados grid on the side of the elbow. The two measurement grids were combined into one table for this assessment. The final grid used in the assessment is illustrated in Figure 4.

FIGURE 4: ULTRASONIC THICKNESS READINGS FROM INSPECTION SAVED TO A GRID; THICKNESS VALUES ARE USED IN THE FFS ASSESSMENT; THE COLOR MAP SHOWS THE RELATIVE THICKNESS GRID VALUES.

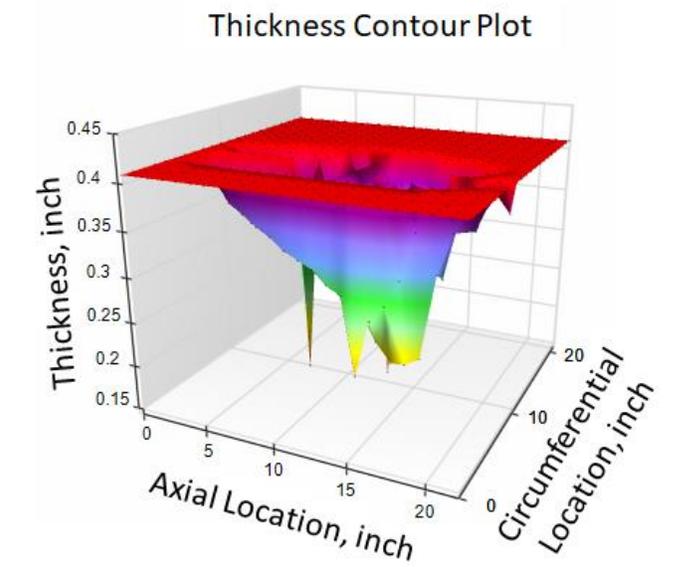
FIGURE 5: 3D CONTOUR PLOT OF THE THICKNESS GRID; THICKNESS VALUES ARE EXAGGERATED IN THIS PLOT.

The same thickness grid is shown as a 3D contour plot in Figure 5. The measured thickness is exaggerated in the vertical direction of the plot, which can help to visualize the metal loss being evaluated.

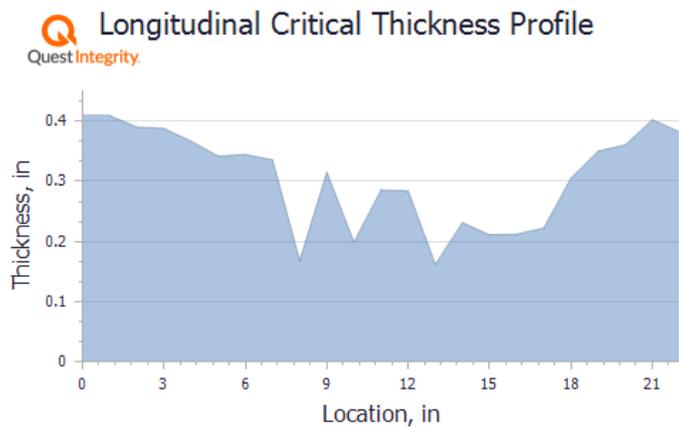
Part 5 of API 579 provides procedures for evaluating local metal loss in a component. When UT thickness measurements in a grid are available, a CTP approach is used. Two CTPs are obtained from the thickness grid: longitudinal (sweep) and circumferential. The longitudinal CTP is the minimum thickness in each column of the thickness grid. Likewise, the circumferential CTP is the minimum thickness in each row of the thickness grid. A remaining strength factor, RSF, is calculated at each incremental span along the longitudinal CTP, which assesses the hoop stress capacity of the damaged elbow cross-section. Figure 6 shows the longitudinal CTP, and Figure 7 shows the circumferential CTP for this elbow. The thickness grid is 22 inches long for the longitudinal CTP, and the thickness grid is 21 inches wide for the circumferential CTP.

FIGURE 6: LONGITUDINAL CRITICAL THICKNESS PROFILE.

Using the longitudinal CTP, the lowest RSF value in the local metal loss area is compared with an allowable RSF, RSFa, commonly 0.9. If the computed value is less than the allowable value, a reduced maximum allowable working pressure,

In the case of the elbow examined here, the calculated RSF was 0.640, leading to a reduced MAWPr. However, the piping was designed with extra thickness and is operated at a pressure less than the computed MAWPr, so the Level 2 assessment criteria were satisfied for the current condition of the elbow. Figure 8 shows a comparison of the elbow design pressure, the computed MAWP, and the reduced MAWPr values. The higher MAWP value shows the extra original capacity in the elbow design before the metal loss damage occurred. The reduced MAWPr value is still slightly above the design pressure, so some additional future metal loss can be tolerated and still satisfy the Level 2 local metal loss assessment. The remaining life analysis is discussed in the next section.

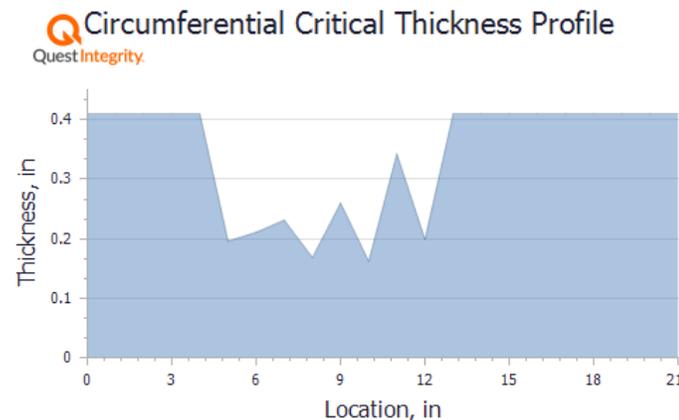
FIGURE 7: CIRCUMFERENTIAL CRITICAL THICKNESS PROFILE.

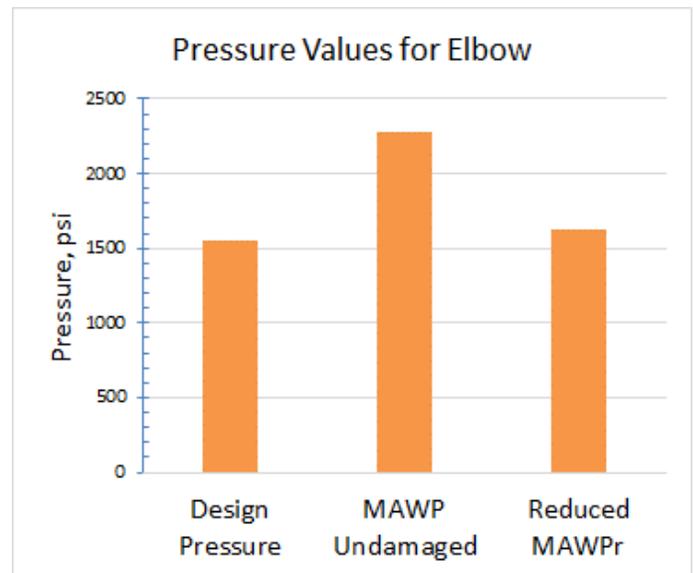
FIGURE 8: COMPARISON OF THE ELBOW'S DESIGN PRESSURE, COMPUTED MAWP AND REDUCED MAWPr VALUES.

Within the AIM database, an integrity operating window (IOW) was defined using the MAWPr from the assessment to monitor and alert the operator of any pressure exceedance. The system is designed to inform the user of the moment, volume, and length of time for each pressure exceedance, so that these values are recorded.

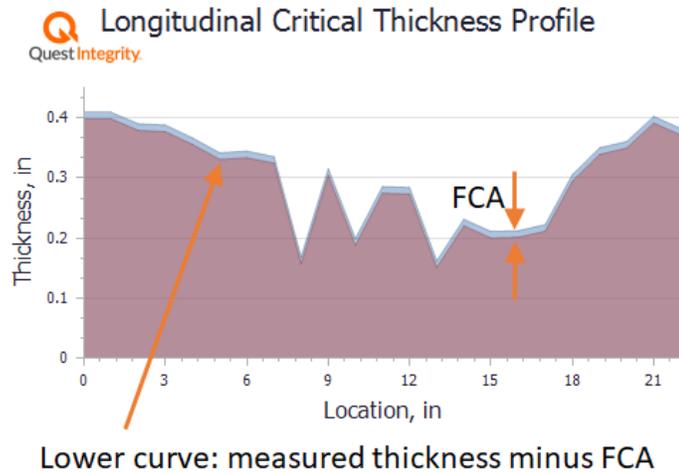
Based on the UT readings described here and the corrosion rate estimated by the operator, the elbow was estimated to have 3.5 years of remaining life or 0.011 inches of allowed future corrosion. Figure 9 shows the updated longitudinal CTP where the estimated FCA has been subtracted from the measured thickness readings. The tolerable FCA is a relatively small amount compared to the elbow’s nominal thickness and current thickness measurements. This result allowed the operator to confidently adjust the inspection schedule for the TMLs at the elbow and along the same piping system.

FIGURE 9: TWO LONGITUDINAL CRITICAL THICKNESS PROFILES: MEASURED CTP AND UPDATED CTP WITH ESTIMATED FUTURE CORROSION ALLOWANCE.

For the elbow assessed here, the actual measured thickness inspection grid was used and the future corrosion allowance (FCA) was increased until the results no longer satisfied the Level 2 FFS criteria. Increasing the FCA reduces the remaining thickness by a uniform amount for all points in the thickness grid. The CTP is updated for the new thickness values to compute the RSF and MAWP. This method provides an estimate for the postulated allowed amount of additional corrosion before a de-rate, repair, replacement or a Level 3 FFS analysis is conducted.
