# ADVANCEMENTS IN PIGGING VALVE & ULTRASONIC TOOL TECHNOLOGIES ALLOW FOR IN-LINE INSPECTIONS OF FORMERLY UNPIGGABLE LINES

## ABSTRACT

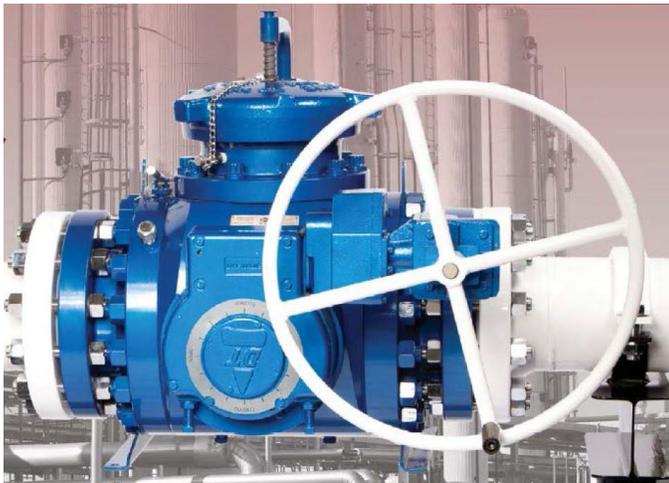
**Figure 1: Argus Pigging Valve [5]**

For most facilities, space is limited. Space used for 20-foot launcher and receiver barrels could be space used for additional assets for a terminal or space needed to complete facility maintenance. Another option is a 5-foot launcher barrel and receiver, but the traditional in-line inspection tools will not fit and would still require a complete skid install. In most cases, a launcher and receiver are not going to be practical to install inside a facility because operators would need multiple receivers and launchers for numerous lines. Argus valves, as shown in Figure 1, are an in-line solution which do not take up additional area. They can be installed in tight areas and need only small modifications to existing piping systems.

This innovative, double block and bleed valve has several benefits where it has the capacity to:

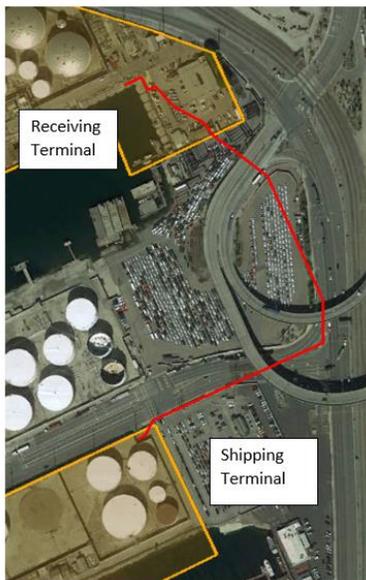
Figure 2: Selected line for Argus Valve Installation

The pipeline Andeavor selected is an 8-inch diameter line, installed in 1961. It transports oily water between two of Andeavor's facilities in California, as shown in Figure 2. It is 2,007 feet in length, with a Maximum Operating Pressure (MOP) of 720 PSI. The Normal Operating Pressure of the line, however, is only 50 PSI.

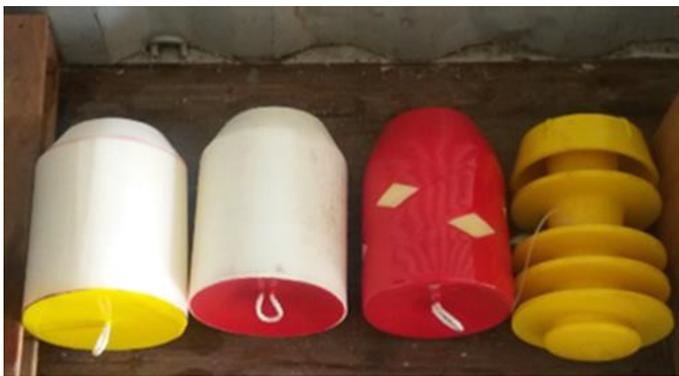
**Figure 7: Maintenance Pigs**

To test the functionality of the Argus pigging valves, and the passability of the line, Andeavor planned to initially run several maintenance pigs through the line. As shown in Figure 7 below, from left to right, the first two pigs were low density foam pigs, followed by a medium density foam pig, and then a poly pig. The first low density foam pig run yielded a torn, damaged pig saturated with oily debris. With every subsequent pig run, there was a reduction of debris in front of the pig. The photos of the runs were sent to Quest Integrity to verify that the line was ready for a smart tool. Once the poly pig (last pig on the right) emerged with acceptable abrasion and continued reduced debris in the front, Quest Integrity analysts were confident that the tool with 25% tool/ID clearance would pass. Line cleanliness was also examined and accepted by Quest Integrity to ensure the line was clean enough to obtain good ILI data.

This maintenance pigging practice was able to clean the line and remove about 50 years of debris build up, enhancing line integrity. This created a clean passage for the Quest
