# Heater Tube Cleaning and Verification: The Effect of Fouling on Heater Services That Are Prone to Coking From a Process Engineer's Perspective

By Tom Gilmartin, Zerosumheater and retired fired heater and flare advisor for BP

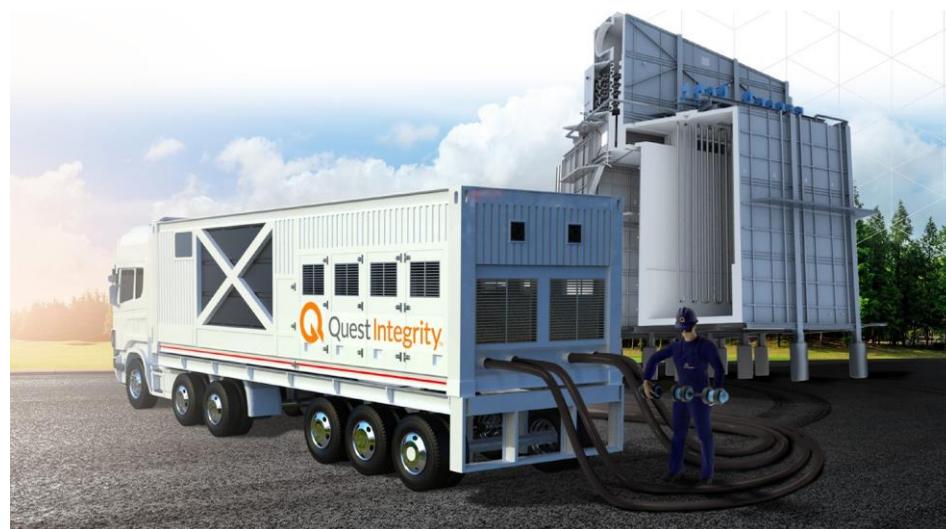
Figure 1. Quest Integrity ADCV™ service

ADCV™ replicates the one key benefit that the burn technique had and adds a new one: it provides a detailed map of where the coke was in the coil together with positive verification that coke has been removed at the end of the cleaning process.

1. Initial ADCV™ survey – where is the fouling located? Ultrasonic-based intelligent pig maps the location and thickness of the fouling.
2. Mechanical cleaning team removes the bulk of the fouling using studded pigs.

3. Cleanliness verification using the intelligent pig then checks the result, fine tuning the mechanical pigging work with additional cleaning that identifies tubes or spots with fouling. Additional cleaning is performed as needed based on the intelligent pig results. Once it's confirmed all fouling has been removed, tube integrity data is collected using an FTIS™ tool to determine the thickness of the pipe wall and whether any deformations exist such as bulging or creep.

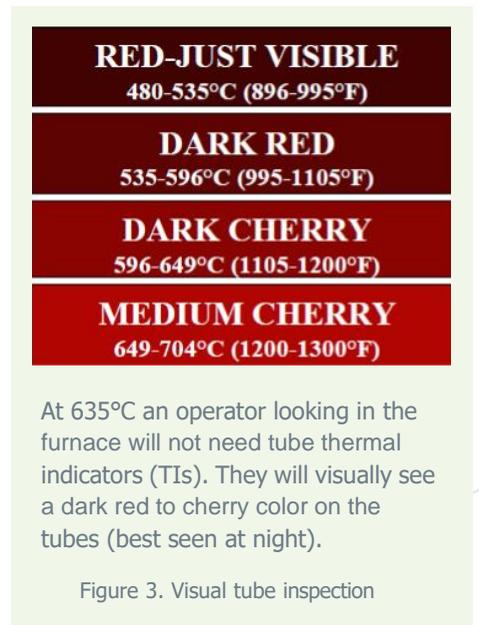
There is one other metric that can be used. Visual inspection of the firebox (see Figure 3). It is possible to see advanced cases of fouling (the 5mm coke case). Thermography adds even more quantitative information.

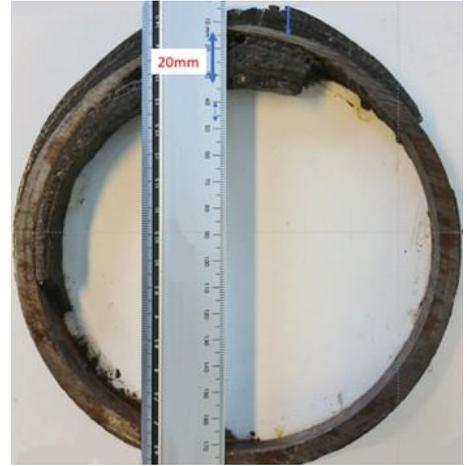
Figure 4. Coked tube

A special case is given in Table 5 - here the coking thickness is increased to 7mm. On heaters with significant localised coking, this is not an abnormal thickness to find (in fact 10-15mm is more common). It is usually found and measured when tubes have been removed after a coking event and can be measured directly. This case is offered as it shows how just 2mm of added coke can have a dramatic effect on heater operation.

Note: That for the case of 7mm coking, there will be no sensible process moves available at this tube temperature. Heater will need to be scheduled for an unscheduled pigging run to clear the coke. At 730-750 C the affected tubes would be readily observable by an operator. Estimated time of the unit outage would be 10 days. This time does not include the removal and replacement of damaged tubes. Commercial cost would be a multiplication of the rate cut example.

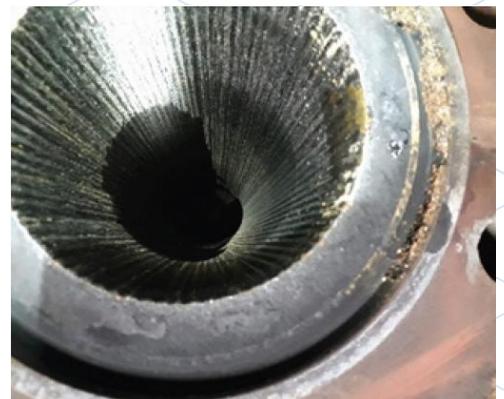
Figure 9. Damage (grooving) on tube internal surface from over-cleaning

For stubborn areas of coke, there is a risk of damaging the actual tube in clean areas - leaving scored grooves in the tubes. For stainless steel in particular, this can be a problem because the material is softer than a Cr steel and may have a different corrosion allowance compared to a ferritic material (1mm compared to 3mm with 5Cr). Advanced Decoking and Cleanliness Verification (ADCV™) has the advantage of identifying the key areas of coke and allowing close attention of the pigging cycle to only those areas.
