## CASE STUDY

# Cleaning, Inspection and Assessment of Steam Reformer Convection Coils Now Possible

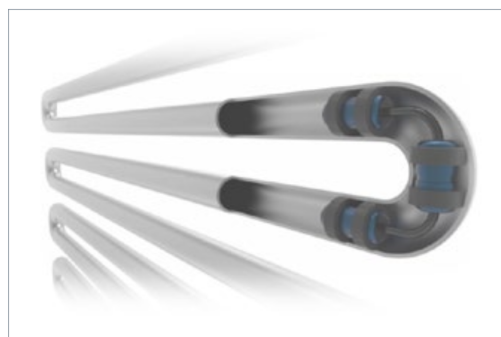
Figure 1. FTIS Smart Pig

To mitigate possible future tube failures and obtain much needed integrity data, a Methanol plant located in the Middle East contacted Quest Integrity to perform an FTIS<sup>®</sup> (Furnace Tube Inspection System) smart pigging inspection (see Figure 1) and fitness-for-service screening assessment on 100 PNG Preheater coils. The coils had never been cleaned before and light internal fouling was suspected given the number of years in operation. As such, Quest Integrity was requested to clean the coils using its Advanced Mechanical Cleaning Technology in addition to pumping the FTIS tool through the coils.

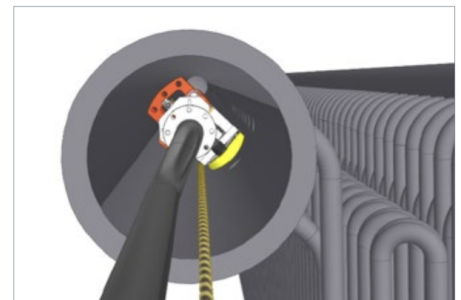
Figure 2. HDS Inside a Common Header

As with many steam reformers, common headers were attached to the inlet and outlet of each coil. This added to the complexity of the project, since the cleaning pigs and FTIS tool would need to travel through the header first for entry into the coils. For successful navigation through the heater, Quest Integrity's Header Delivery System (HDS) was installed inside the inlet and outlet common headers of each coil. The HDS effectively connected the coils via hoses to the water pumps installed on Quest Integrity's cleaning truck (see Figures 2 and 3). This created a closed loop system, allowing water to enter the coils to provide a couplant for the ultrasonic inspection while also propelling cleaning pigs and the FTIS tool through the coil via the cleaning truck pumps.

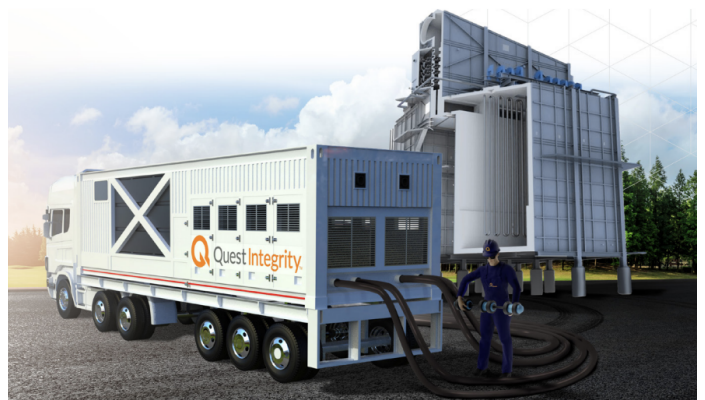
Figure 3. Typical Fired Heater Set Up for Advanced Cleaning and FTIS Inspection

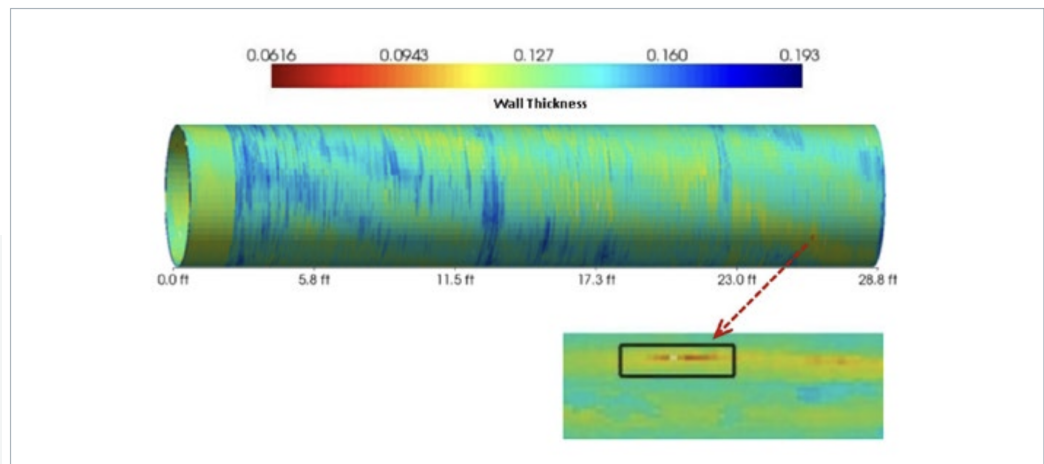
The FTIS inspection revealed moderate internal and external localized wall loss upwards of 40 percent in numerous pipes (see Figure 4). General internal wall loss upwards to 26 percent was also present in the 180-degree return bends. The result of the engineering screening assessment showed that the coils were fit for service for the next four-year operating period. A remaining life assessment was also performed on each coil as part of the screening assessment, showing an estimated remaining life of 15 years with a recommendation to reinspect in four years to monitor corrosion rates and detect any other localized damage that may affect coil integrity.

Figure 4. Wall Thickness Plot Showing Localized Wall Loss
