# NEW POSSIBILITIES

**Tim Haugen, Quest Integrity, USA,** outlines the benefits of ultrasonic-based smart pigging inspections and cleaning on steam reformer convection coils in the ammonia, methanol and hydrogen industries.

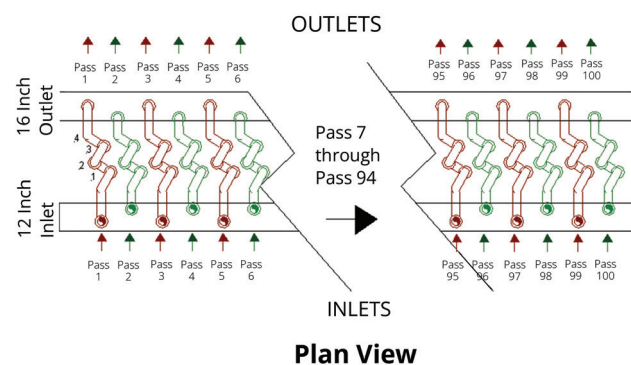
**Figure 1.** Natural gas preheater section.

To mitigate possible future tube failures and obtain much needed integrity data, a methanol plant located in the Middle East performed an automated in-line 'smart pigging' inspection and fitness-for-service screening assessment on 100 natural gas preheater coils (Figures 1 and 2). The coils had never been cleaned before and some internal fouling was suspected given the number of years in operation. As such, the solution provider selected to perform the inspection and assessment was also asked to clean the coils using an advanced mechanical cleaning and pumping technology in addition to pumping the smart pigging inspection tool through the coils.

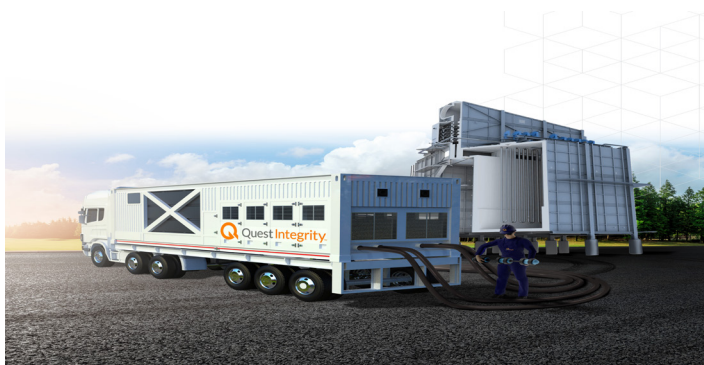
**Figure 4.** Set up for coil cleaning and inspection (typical process heater).

To overcome these hurdles, a header delivery system was installed inside the inlet and outlet common headers and attached to each coil. The delivery system effectively connected the coils via hoses to the water pumps installed on the cleaning truck (Figures 3 and 4). This created a closed loop system, allowing water to enter

the coils while keeping the headers dry. The water inside the coils provided a couplant for the ultrasonic inspection, while also propelling cleaning pigs and the inspection tool through the coil via the cleaning truck pumps.

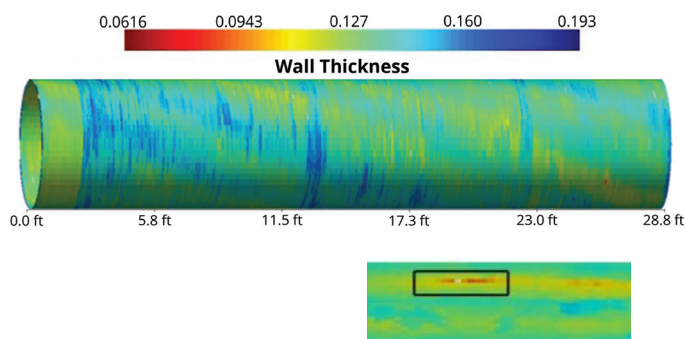
**Figure 5.** Tube thickness plot showing localised wall loss.

The high-resolution inspection revealed internal and external localised wall loss upwards of 40% in numerous pipes (Figure 5). General internal wall loss up to 26% was also present in the 180° return bends. The result of the engineering screening assessment showed that the coils were fit for service for the next four-year operating period. A remaining life assessment was also performed on each coil as part of the screening assessment, showing an estimated remaining life of 15 years with a recommendation to re-inspect in four years to monitor corrosion rates and detect any other localised damage that may affect coil integrity.

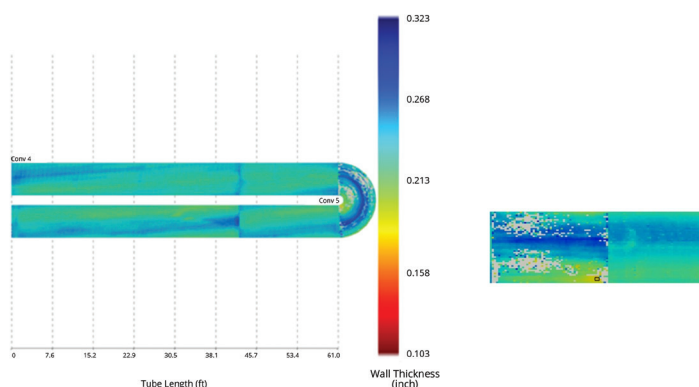
**Figure 6.** 2D thickness plot showing localised wall loss in return bend.

In another instance, unexpected internal wall loss was found on the inside radius of 1D return bends in a feed gas coil (Figure 6). Although the straight pipes were in good condition with minimal wall loss, moderate thinning upwards of 32% wall loss was found in the return bends. This discovery prompted an investigation and root cause analysis.
