CASE STUDY

REMOTE DIGITAL VIDEO INSPECTION (RDVI™) CASE STUDIES

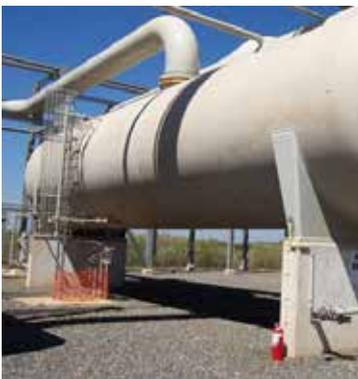
PRESSURE VESSELS

An onshore facility planned a shutdown to carry out an RDVI inspection programme. The primary issues we had to consider were the length of time required to inspect all vessels and the availability of the man power required.

The Quest RDVI In-Spec programme was implemented across all plant vessels using our RDVI specific ITPs and VAPs. Our review with the client revealed that 95% of the vessels were able to be inspected for GVI and CVI purposes and did not require a confined space entry to be performed. For those vessels that were selected for the application of RDVI, strategically selected access points were chosen to ensure key target areas could be accessed to ensure the integrity of the inspection. These inspection points required minimal mechanical intervention, scaffolding, cranes and riggers. As there were no confined space entry elements and small diameter access points were used, a reduced level of isolations was required which further reduced the costs, personnel involved and the HSE risk profile.

The result was a shutdown duration reduced by 51% along with 85% reduction of associated costs. The results from the RDVI inspections were used to form part of the client’s ongoing RBI requirements and strategy for all future shutdowns for both onshore and offshore.

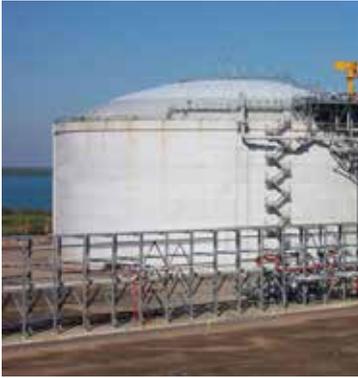
TANKS

A large hydrocarbon storage tank required inspection. There were two main challenges with this tank:

- it had a methane atmosphere and could not be shut down for inspection,
- the only suitable access point available (6 inches) was in the upper centre of the tank.
