# **Engineering Assessment of Deformed Spillway Gate**

David Osuna, Consulting Engineer<sup>1</sup>

<sup>1</sup>Quest Integrity NZL LTD, 69 Gracefield Rd, Lower Hutt 5010, New Zealand

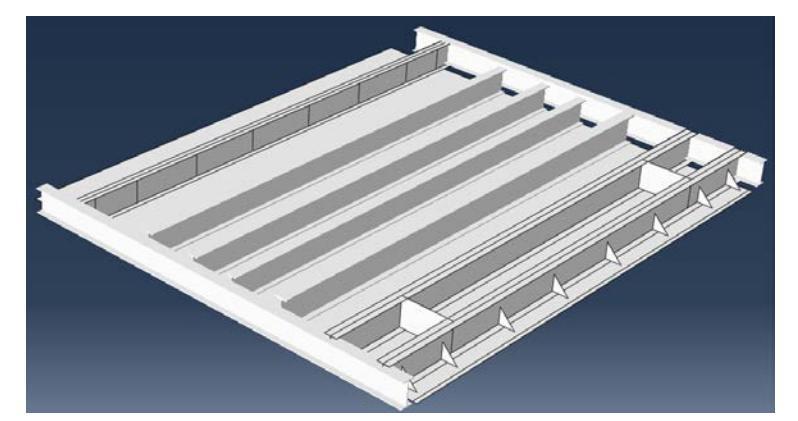
The skinplate of the spillway gate was modelled with shell elements. Similarly, beams A3, A2 and B1 were modelled using shell elements to include the connecting plates between girders A3 and A2 and the triangular reinforcement gussets of girders A3 and B1. Girders A1, B4, B3 and B2 as well as the side joists were modelled using beam elements. An overall view of the as-designed model is shown in Figure 4.

*Figure 4. Overview of the spillway gate model. Connecting plates and triangular reinforcement gussets are highlighted.*

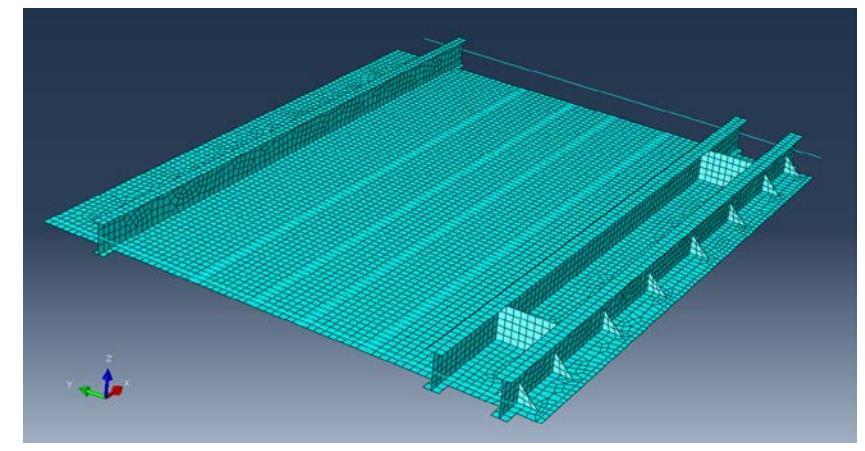
As described in section 3.1, the spillway gate was modelled using shell and beam elements. Table 3 summarises the type and number of elements used and Figure 8 shows the model mesh.

Figure 8. Spillway gate mesh.

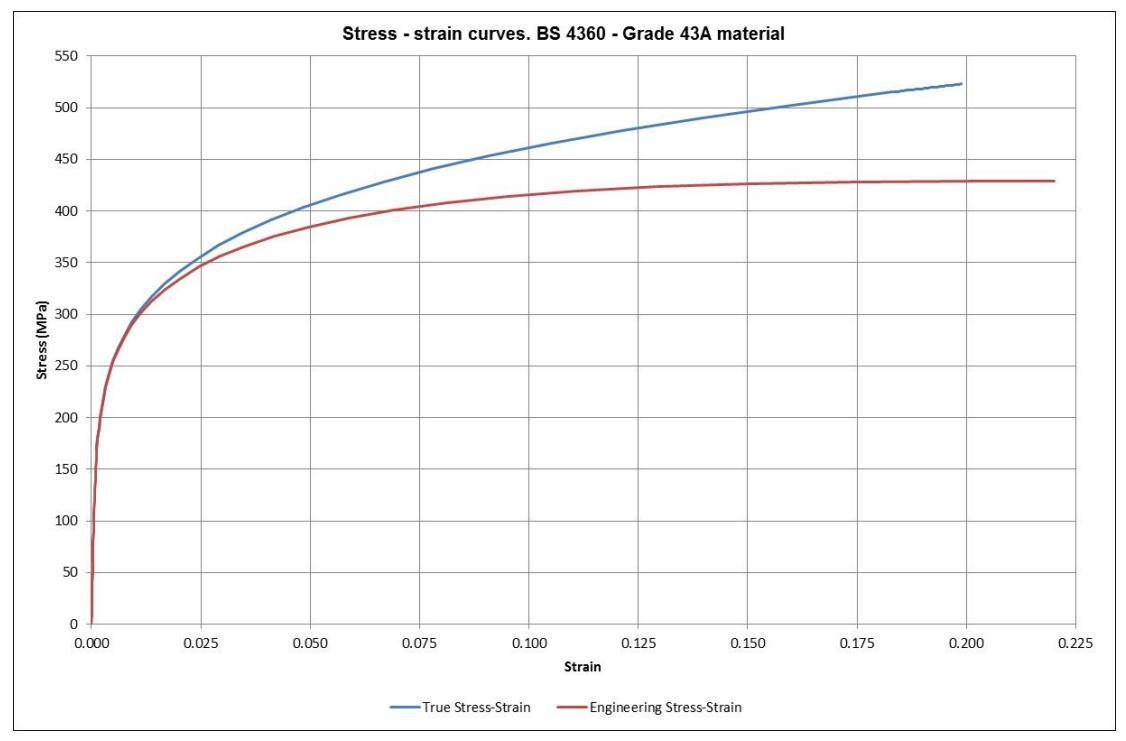
Elastic-plastic properties were generated based on the Ramberg-Osgood methodology in accordance with section F.2.3.2 of ASME FFS-1 using the material properties above. Figure 9 shows the true stress-strain and the engineering stress-strain curve used.

Figure 9. True stress-strain and engineering stress- strain curves. BS 4360 – Grade 43A material.

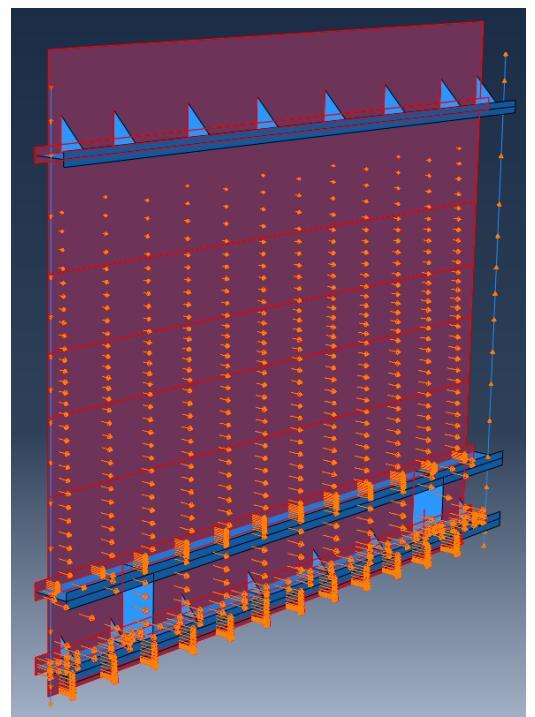
Boundary conditions were applied to the side joists to represent their interaction with the spillway gate slots. Only rotation with respect to their own axes was allowed. Figure 10 shows the hydrostatic load and the boundary conditions applied to the model.

*Figure 10. Hydrostatic load and boundary conditions applied to the spillway gate model. The orange arrows represent the hydrostatic load.*

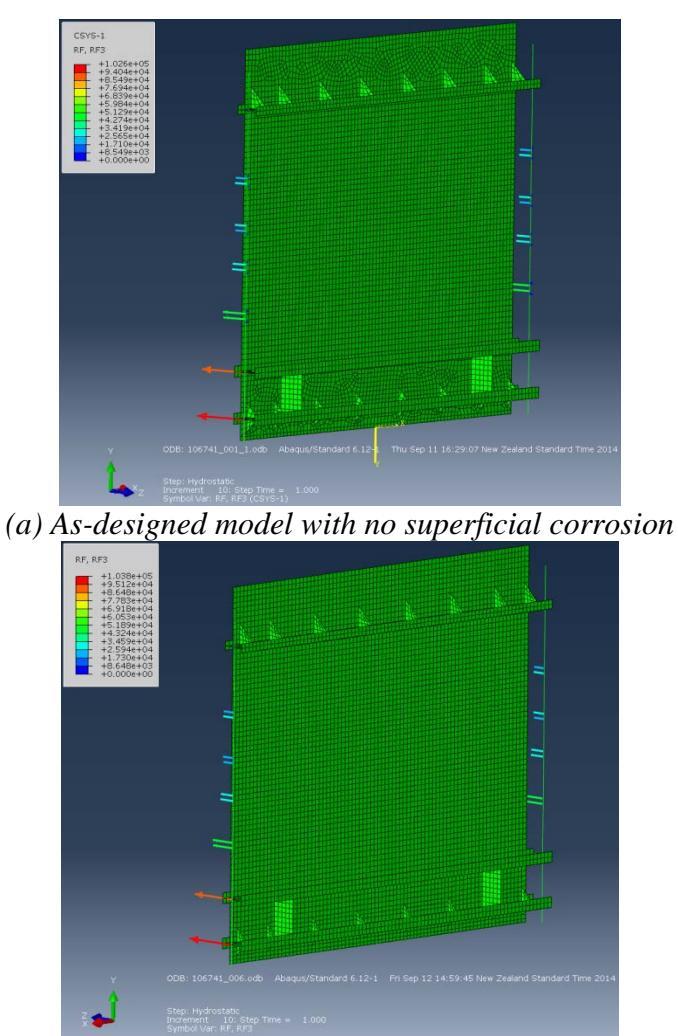
Mighty River Power requested the possible effect of the gate deformation and corrosion on its operation to be assessed. Therefore, reaction forces at the side joists were also extracted from the results for comparison purposes. Table 7 summarises the reaction values obtained from the two Finite Element Models generated. Figure 12 illustrates the direction and the magnitude of the extracted reaction forces. No significant difference in terms of reaction forces was found between the as-designed model with no corrosion and the deformed model with superficial corrosion. *Table 7. Reaction forces*

(b) Deformed model with superficial corrosion Figure 12. Reaction forces to hydrostatic loading. Forces in N.
